Piledriver and 23 Mile Slough Survey Report 2016

Tanana Valley Watershed Association

October 6, 2016

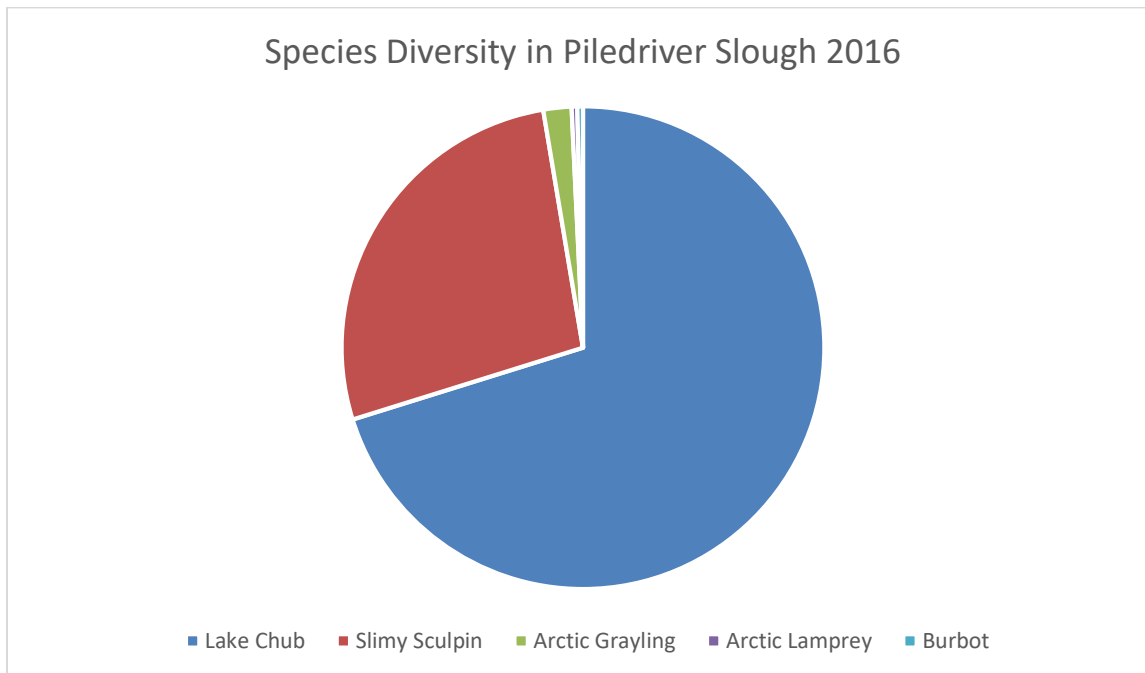
Species Diversity

The most commonly caught fish this year was the lake chub (186 fish). We caught the majority of the lake chub on upper piledriver section and 23 mile slough in June when water levels were low, temperatures were warm, and these fish may have been spawning. The second most commonly caught fish was the slimy sculpin (72). In past years, the Slimy Sculpin has been the most commonly caught fish in each year of sampling on Piledriver slough. Arctic Grayling were caught, mostly on upper piledriver slough as well (5 fish).

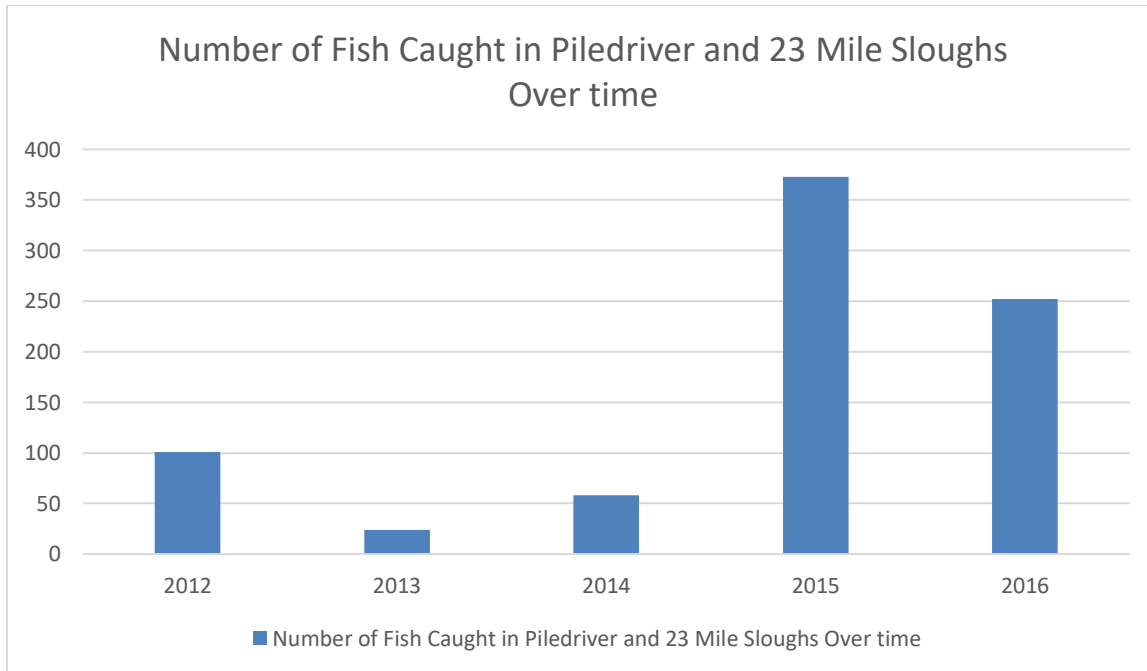
Figure 2: Number of Juvenile Fish Caught in Piledriver and 23 Mile Slough Annually

In 2016 we caught 252 fish. In 2015 the total catch was 373 fish, in 2014 the total catch was 58, 2013 saw 24 fish and in 2012 101 fish were captured. This is due largely to the abundance of Lake Chub that were captured in June of 2016 in 23 mile slough. There is not yet enough data to determine a significant trend in fish numbers.

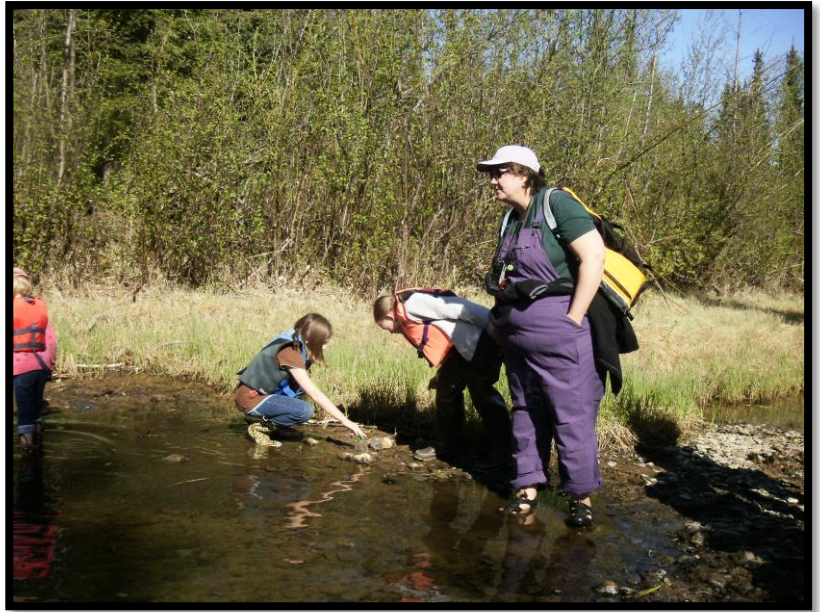
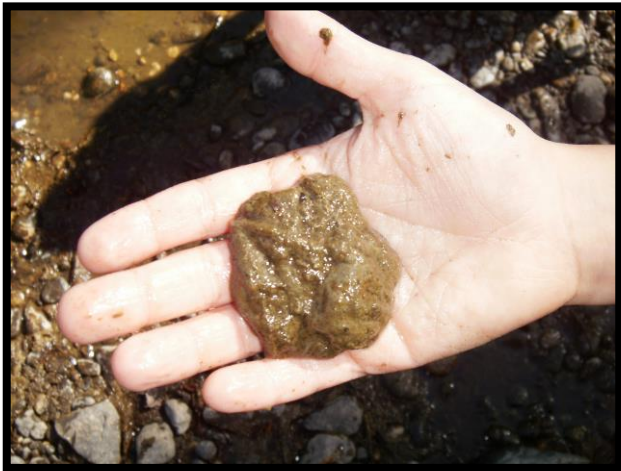
Algae in Piledriver Slough, May 2016

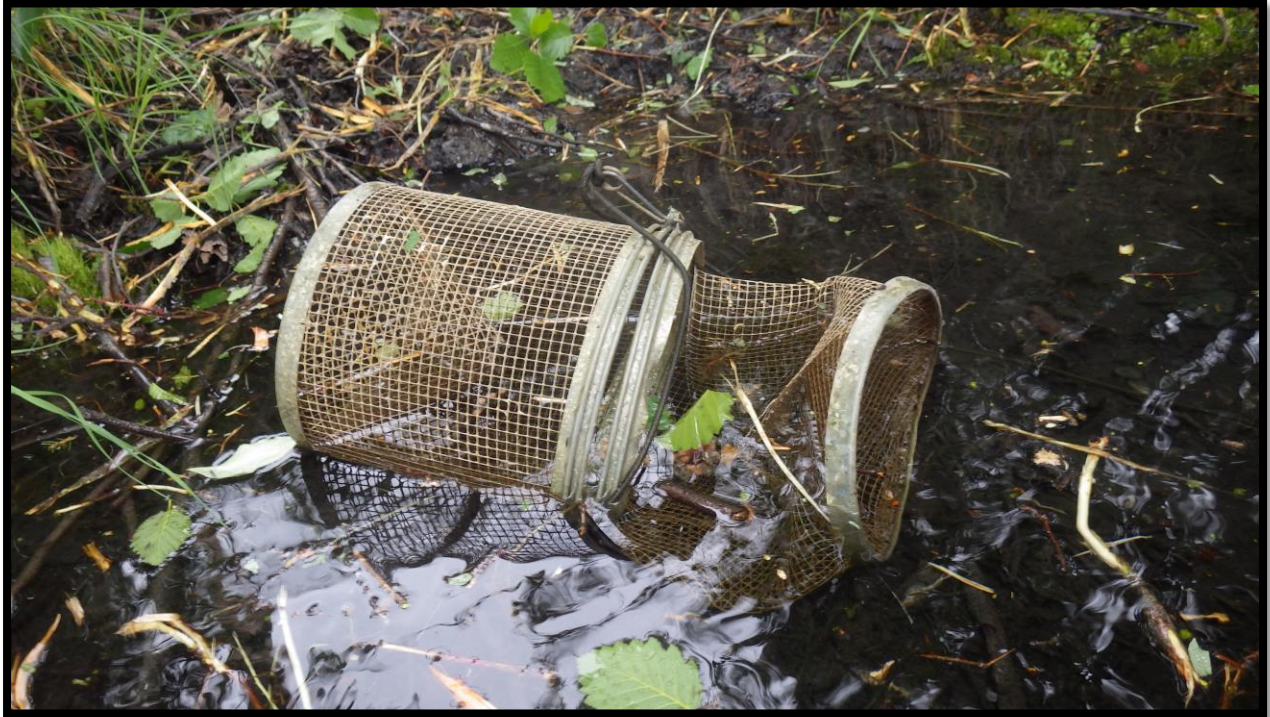
Trap stepped on by a moose, May 2016 Lower Piledriver.
