# Piledriver and 23 Mile Slough Survey Report 2017

Tanana Valley Watershed Association

October 25, 2017

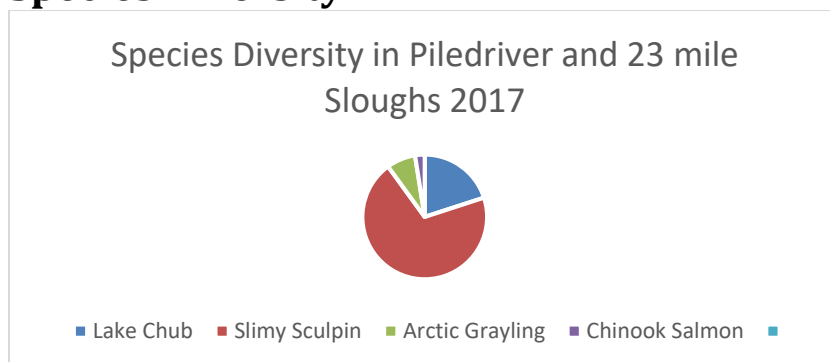
The most commonly caught fish this year was the slimy sculpin (28 fish). We caught the majority of the slimy sculpin on upper piledriver in sites 1 and 2. The second most commonly caught fish was the lake chub (8). In past years, the Slimy Sculpin has been the most commonly caught fish in each year of sampling on Piledriver slough.

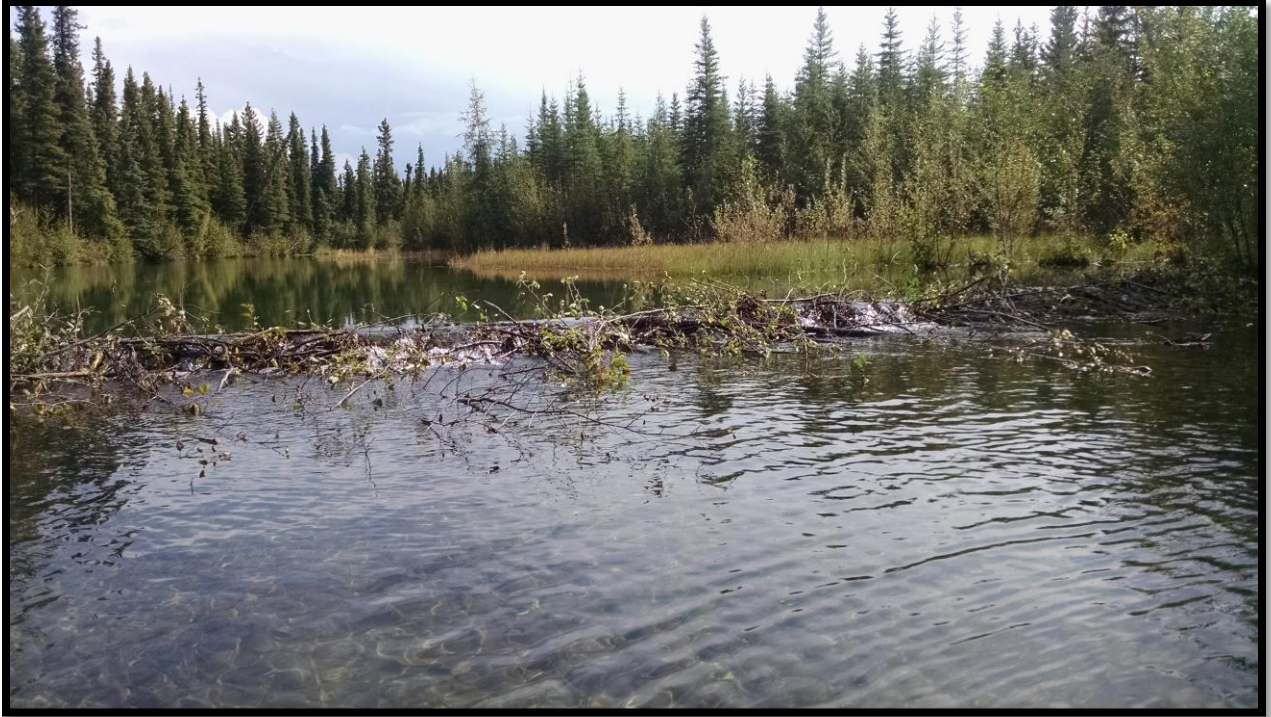
Dam 2 in August 2017

**Site 2: LB152-** Old dam with woody debris buildup. This is an old dam that has naturally built up sediment and woody debris so that it ranges from 1-2 feet in height. 64.60339, 147.08543

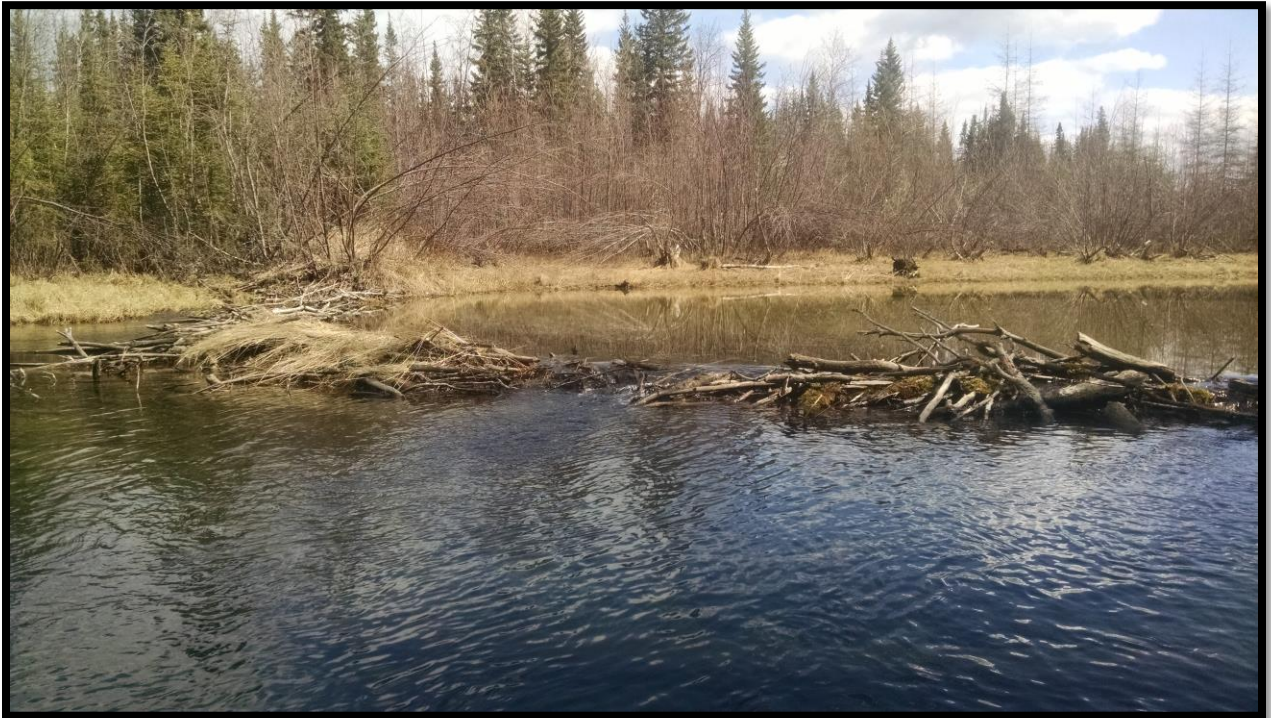
Dam 3 in May

**Site 3: LB153-** Large dam, Height ranged 1-2.5 feet with no passage. 64.60551, 147.08684

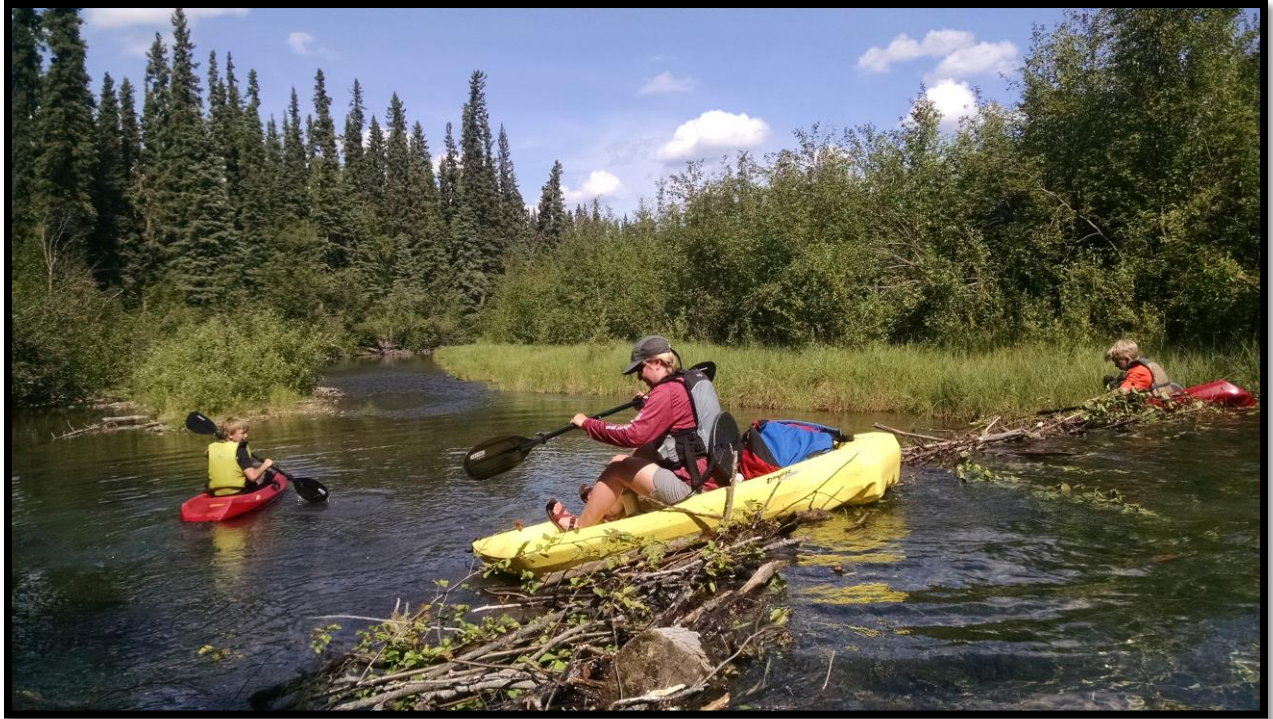
TVWA volunteers Natalie, Ole and Charlie Schuldt navigate beaver dam 3 in June

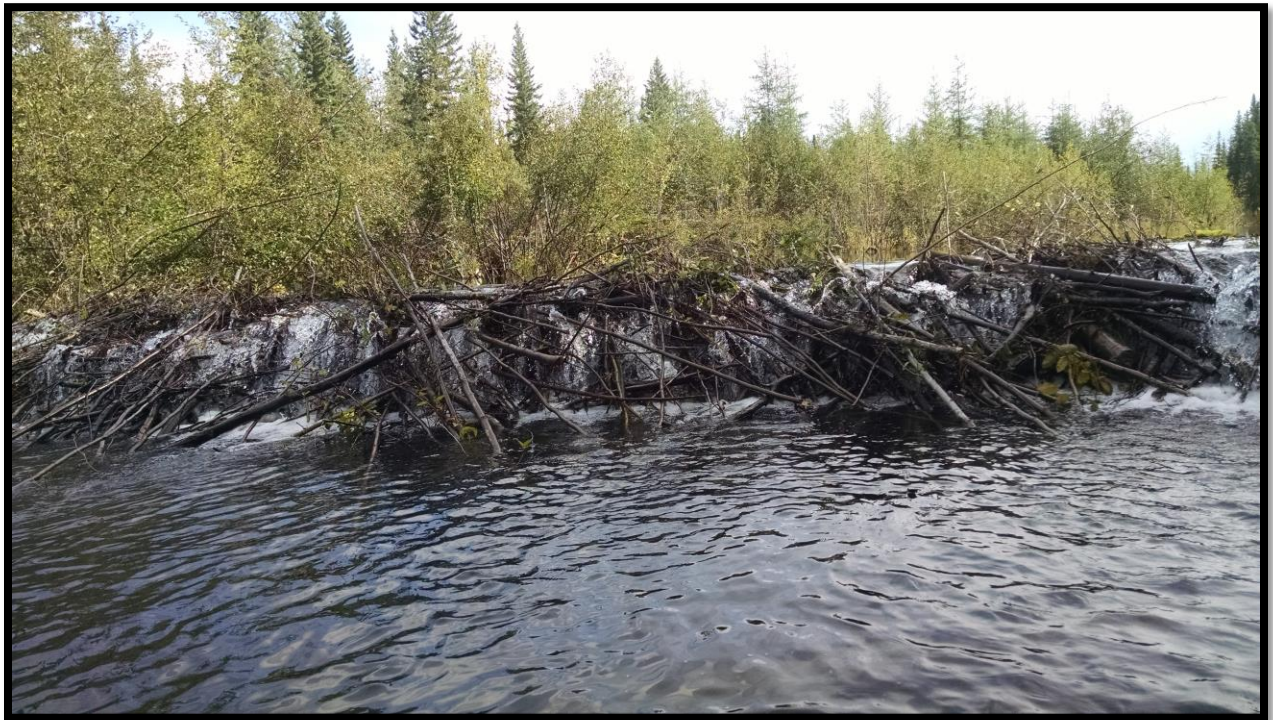
Dam 3 in August 2017

Active beavers were present on Piledriver slough in 2017. We saw sign (chew sticks, vegetation removed, old dams re-constructed etc) during June sampling and during August sampling the two old dam sites (2 and 3) were fully constructed and blocking fish passage.

Because the location of the dams was so close (1/2 mile approximately) from the uppermost limit of the observed spawning area and because without removing the beavers, there was not much point to removing the dam, TVWA contractors made a small breach on August 19 in the dams. We will continue to correspond with ADFG, the Railroad and Mr. Cady about this dam issue in the future.

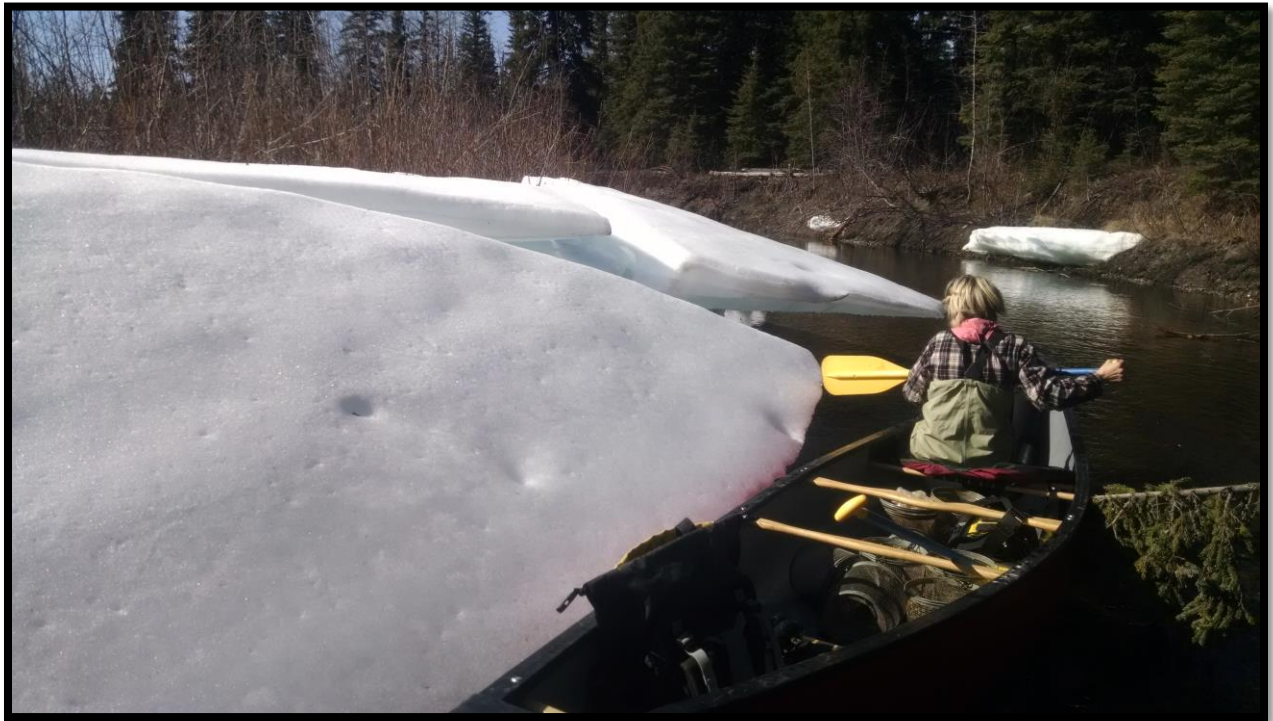
Heather Mirczak canoes through aufeis in May
