Piledriver and 23 Mile Slough Survey Report 2021

Tanana Valley Watershed Association

December 4, 2021

Piledriver Slough Beaver Activity Survey Report 2021

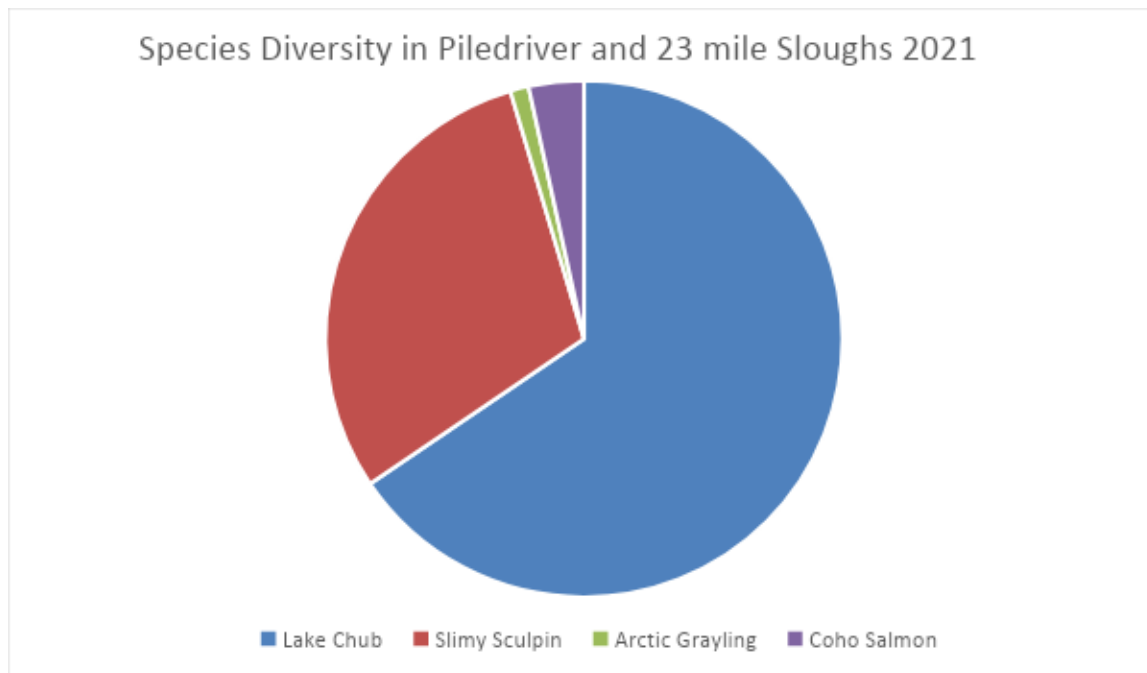
Species Diversity

The most commonly caught fish in 2021 was the Lake Chub (57 fish). The second most commonly caught fish was Slimy Sculpin (26 fish). The third most common fish caught was Coho Salmon (3 fish). The coho salmon captured on lower piledriver slough during the August sampling were the first recorded in this study. These fish were photographed and sent to AKDF&G staff to confirm the identification. Per our permit requirement, TVWA submitted this finding to the anadromous waters catalog and it was confirmed on October 28. In past years, the Slimy Sculpin has been the most commonly caught fish except for when sampling coincided with lake chub spawning events. This

year's high catch of lake chub occurred during the August sampling which is outside of the normal spawning period for this species. We are uncertain why the large aggregation of lake chub were caught then but they were visually observed during this period on Lower Piledriver as well.

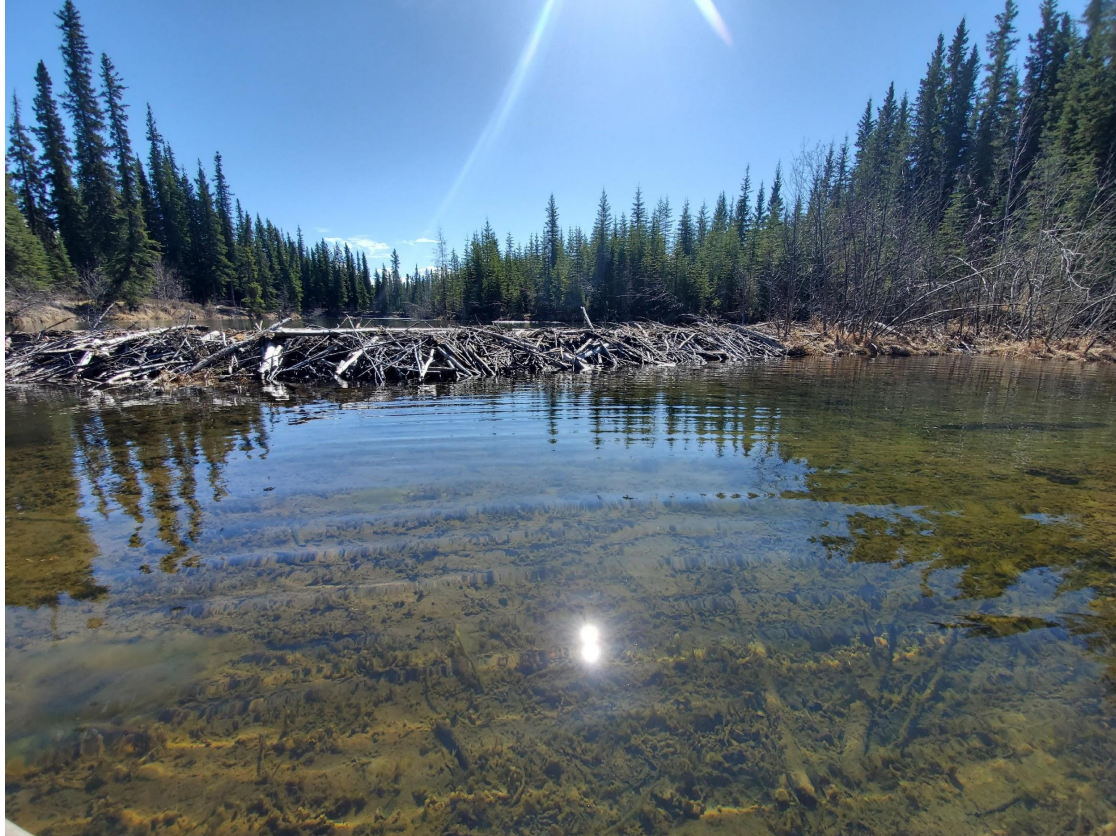
A primary dam was found downstream of the lodge at site 0 and Alan Cady's property. This dam ranged from 2-3 feet tall and blocked all passage during May, June and September floats.

Site 1 from downstream looking upstream during May 2021 sampling, note algae.

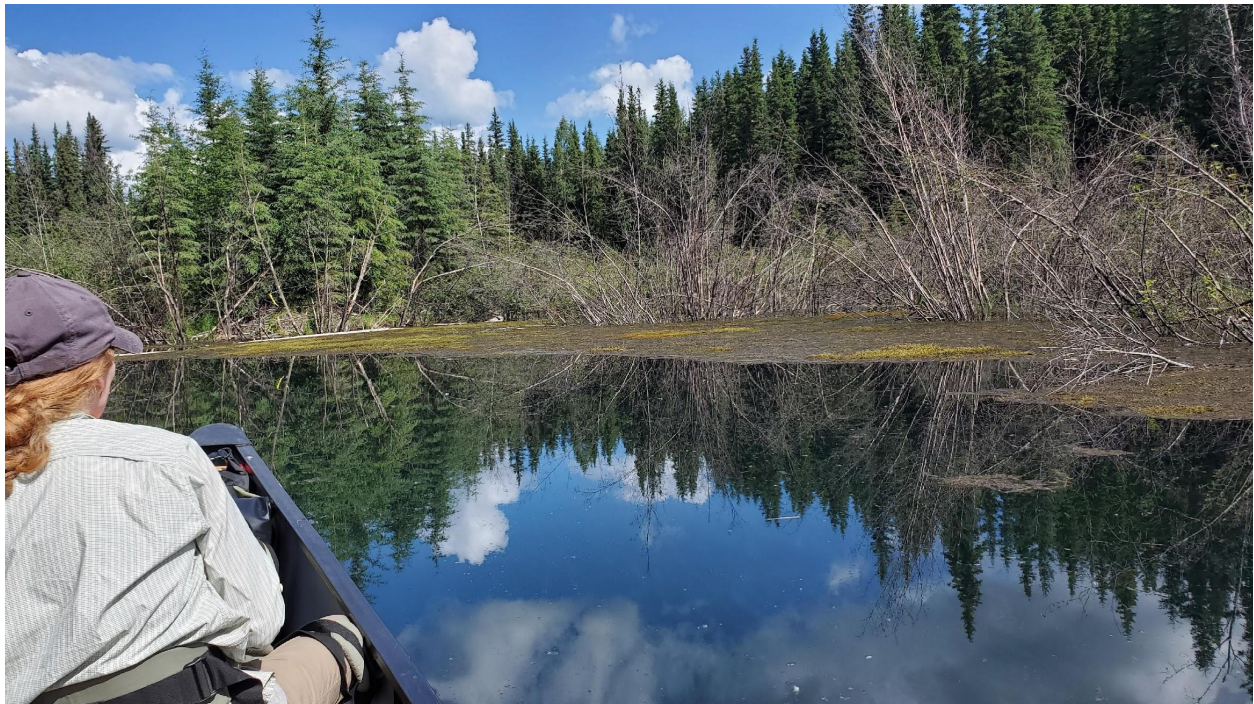
Site 1 seen from upstream during June 2021 sampling, note build-up of algae.

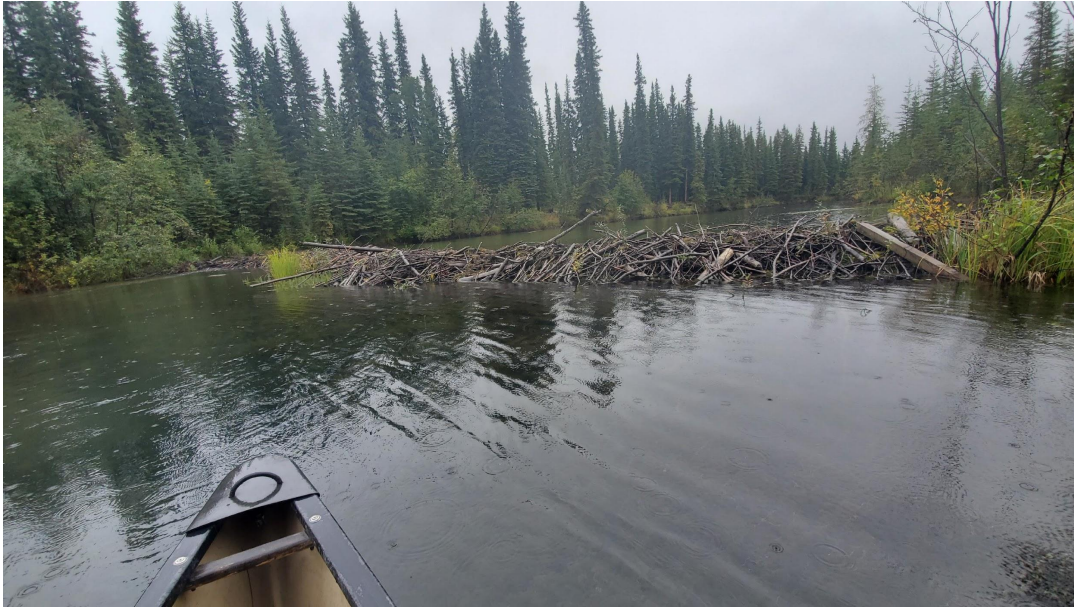
Site 1 from downstream looking upstream during August sampling with higher water.

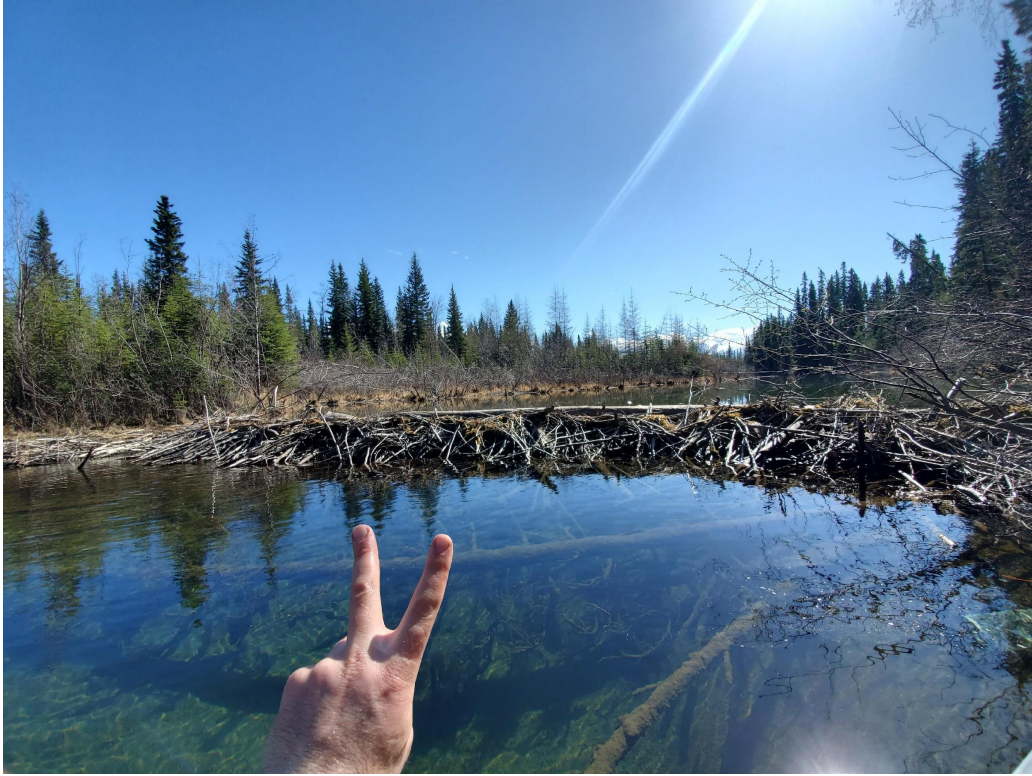
Site 2:

This is the secondary dam associated with site 1 dam. It was observed during all 3 floats and passage was blocked in May and June but breached in August. TVWA did not cause this breach, it appeared to be natural and associated with higher water levels. This dam seemed to be retaining a larger than usual amount of floating algae and debris in June sampling.

Site 2 seen from below during May sampling.

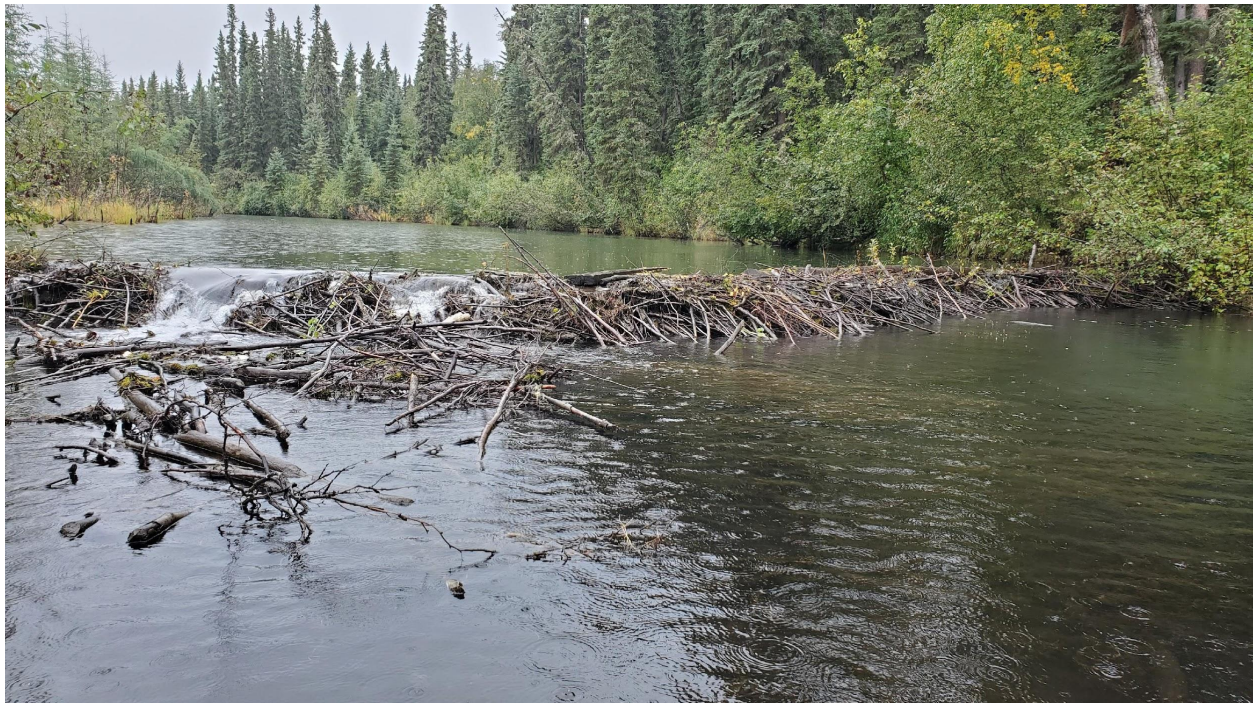
Site 2 seen from below during August sampling, note natural breach.

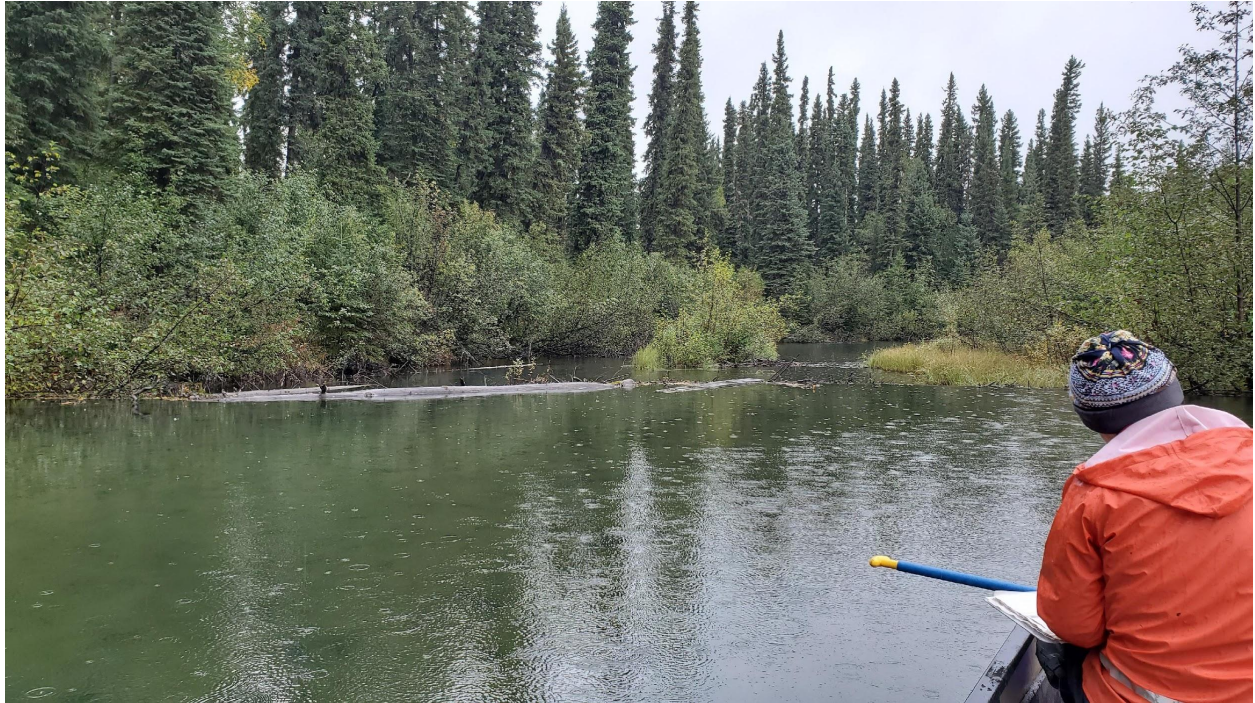
2019 Dam 1:
64.60448, 147.08798

This was a secondary dam located just downstream of Site 2. 2019 was the first year that we have observed a dam at this location and it continued to be inhabited in 2020. It indicates the spread of the beaver colony in this area. In 2021 this dam did not appear to be actively maintained.

2019 Dam 1 looking downstream during August sampling, passage was not being blocked during the high water.

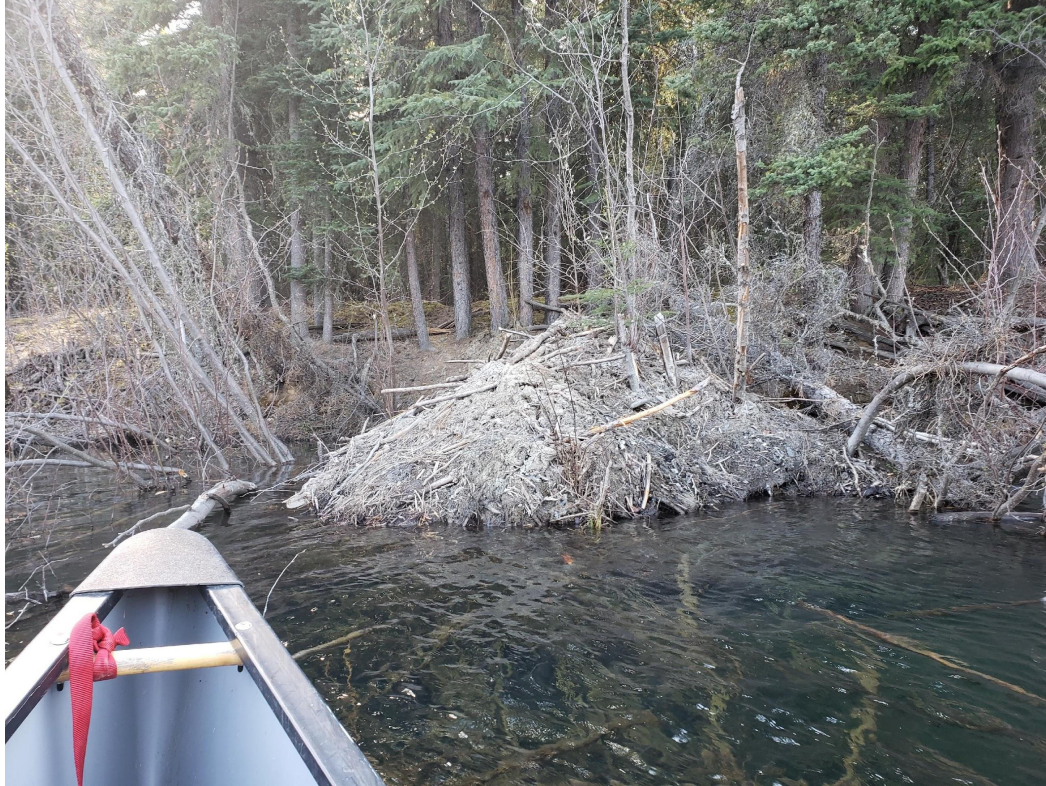
2019 Lodge:

This lodge was noted during September sampling this year. It was a new lodge in 2019, created in what had possibly been an old site and continued to be used in 2021. It was complete with a large feed pile, indicating that the beavers will likely be inhabiting it this winter. This stretch of the slough contains large quantities of beaver fecal content, which can be viewed from the water.

2019 lodge.

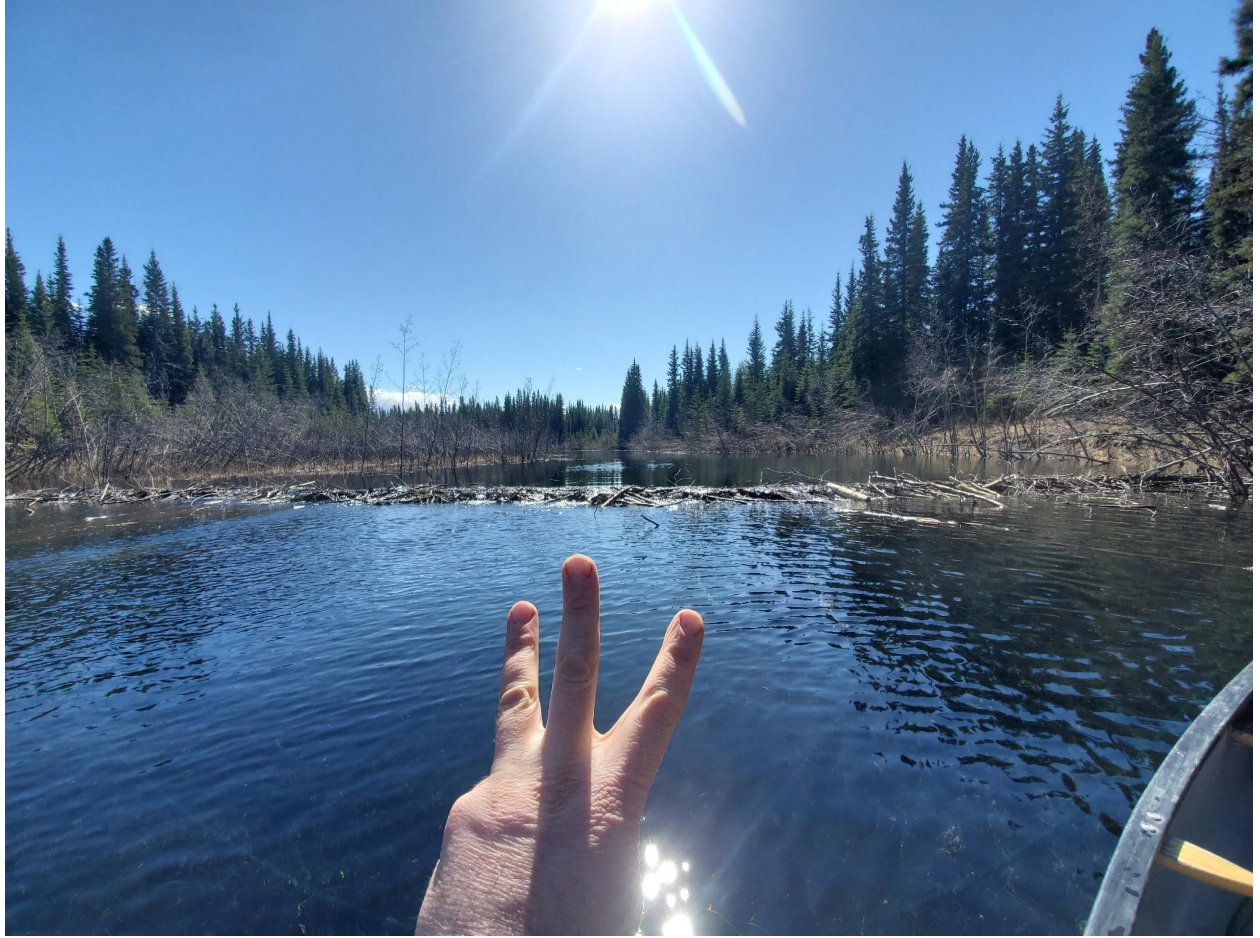
Site 3 (2019 Dam 2):
64.60552, 147.08673

There were a series of old dam sites indicated by remaining rocks and small debris throughout Piledriver Slough. In 2019 we observed some of these sites being reclaimed and added to. This is the case with 2019 Dam 2. It was first observed during June sampling when water was lower but was added to in September. The dam was not blocking passage completely during either sampling but will be monitored. This was not being used in 2021.

Dam 3 during May sampling.

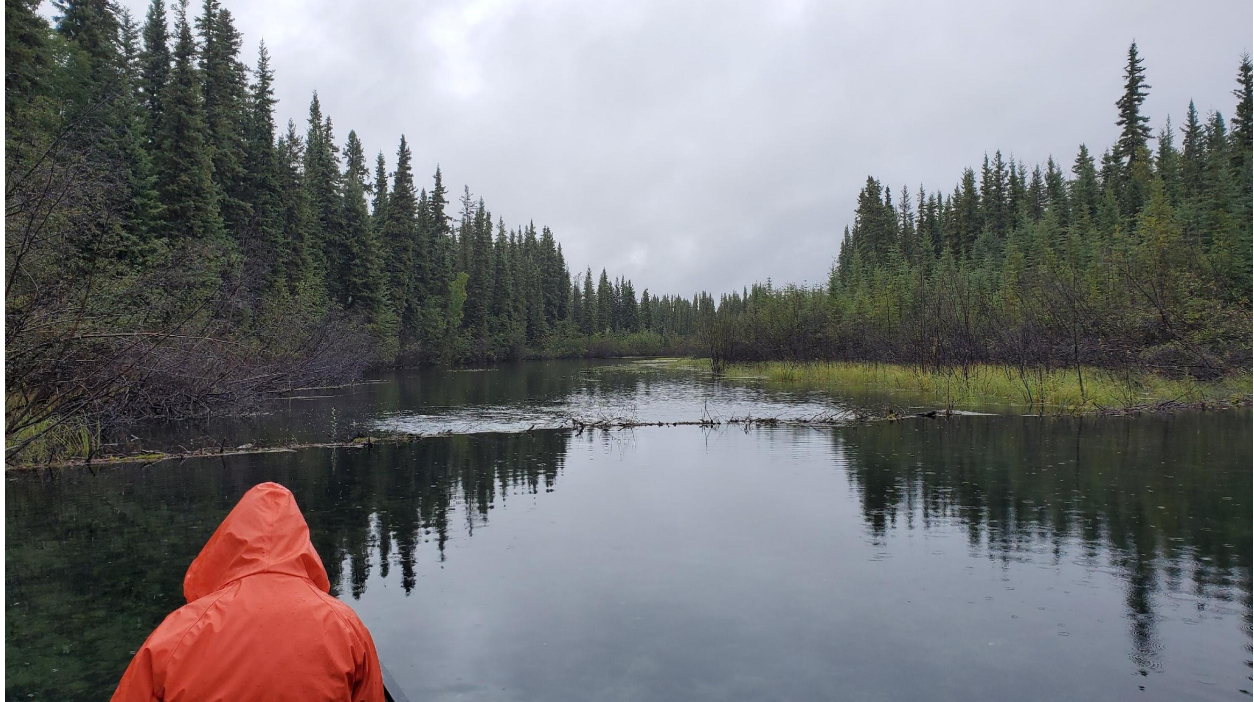
Dam 3 site during August sampling.

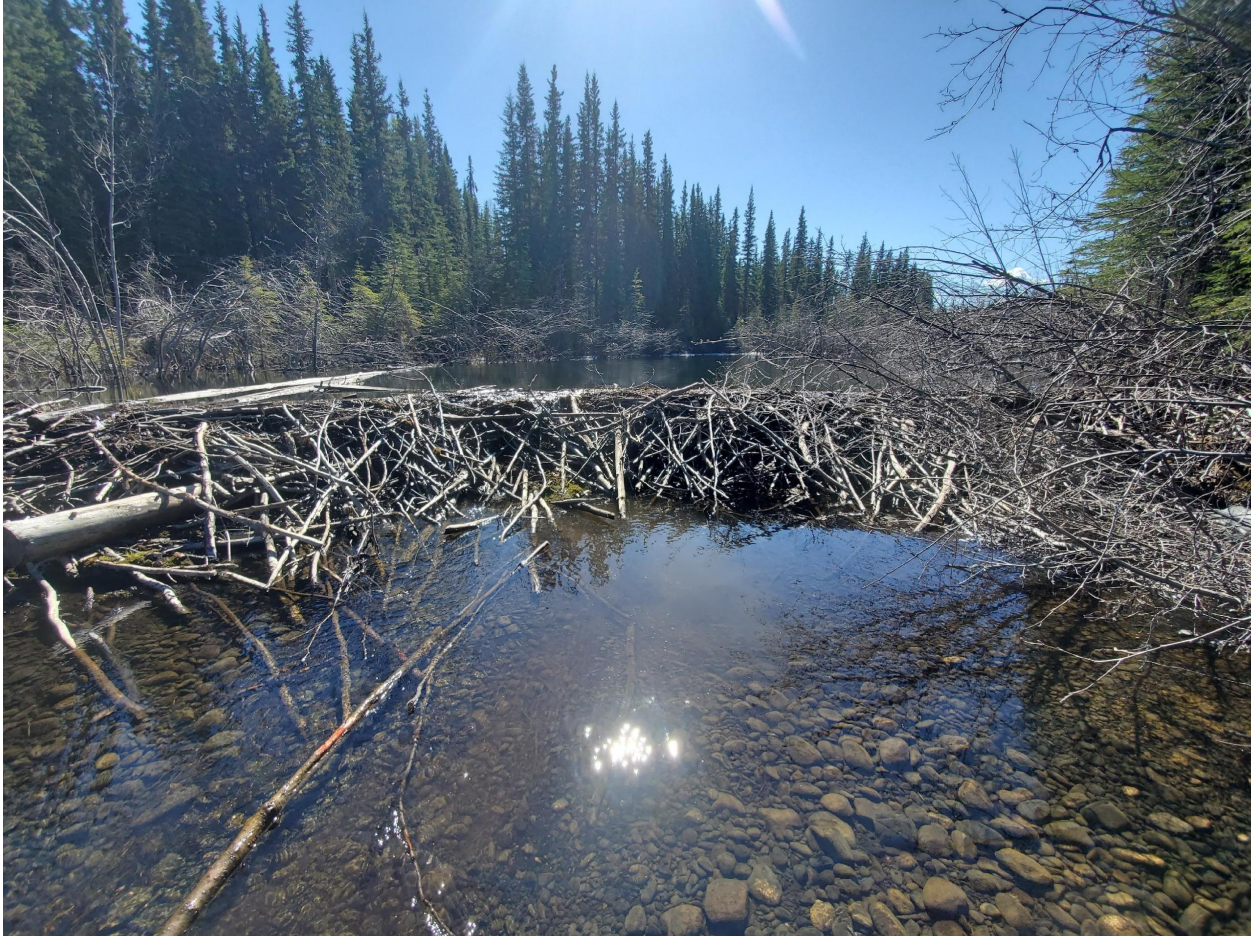
Site 4:

This dam is much farther down Piledriver slough than the first two. It is at a natural narrow spot in the slough and was observed blocking passage completely during all sampling periods.

Site 4 dam from below during May sampling, note the low water.

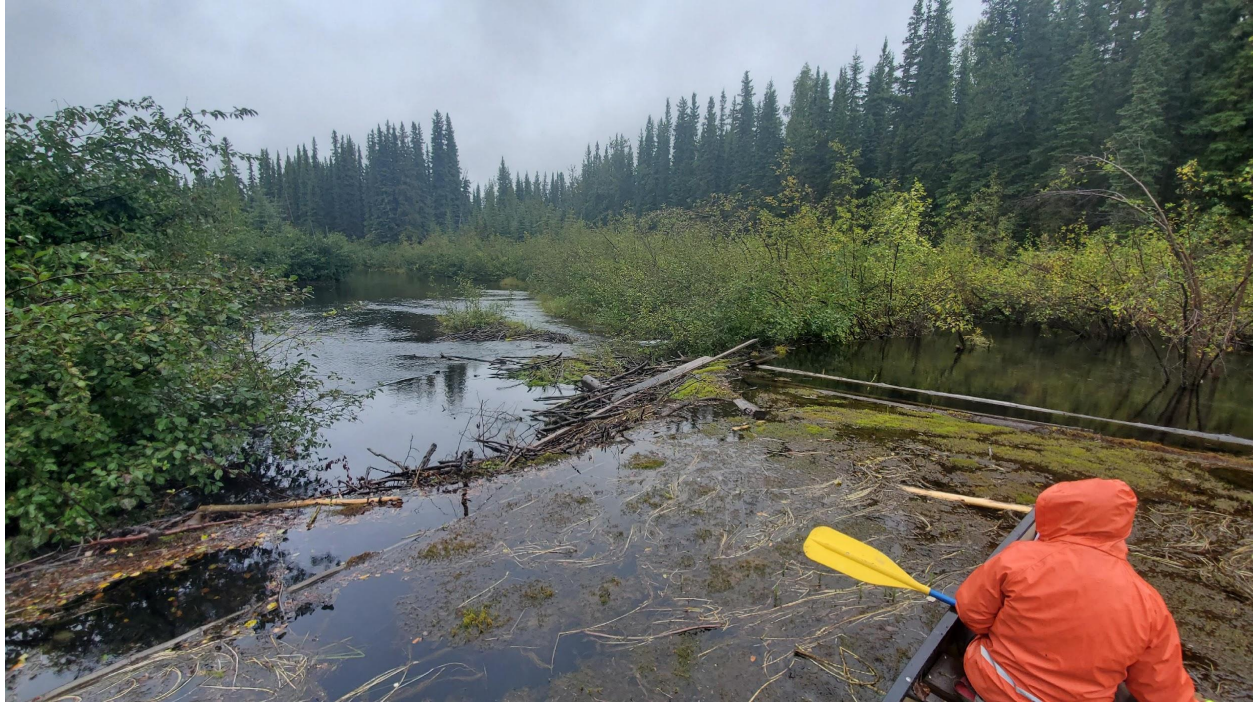
Site 4 Dam during August sampling seen from the top

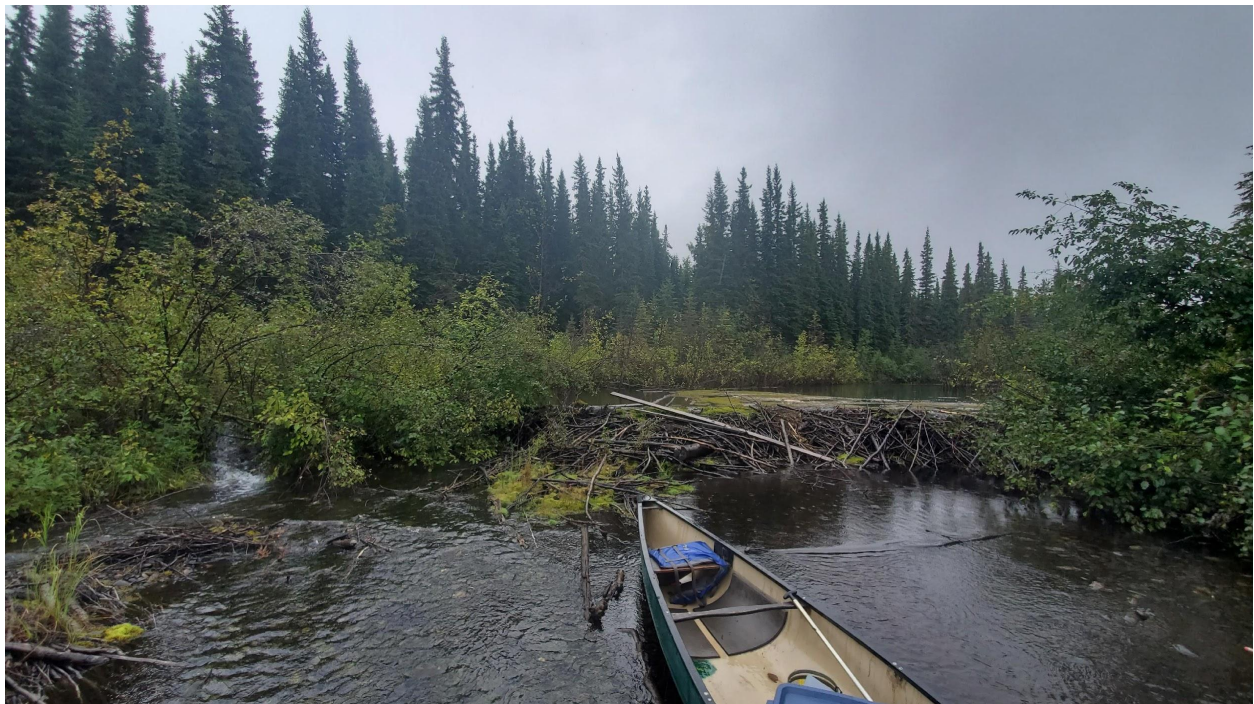
Site 4 dam during August sampling seen from below.
