Piledriver and 23 Mile Slough Survey Report 2018

Tanana Valley Watershed Association

November 7, 2018

Piledriver Slough Beaver Activity Survey Report 2018

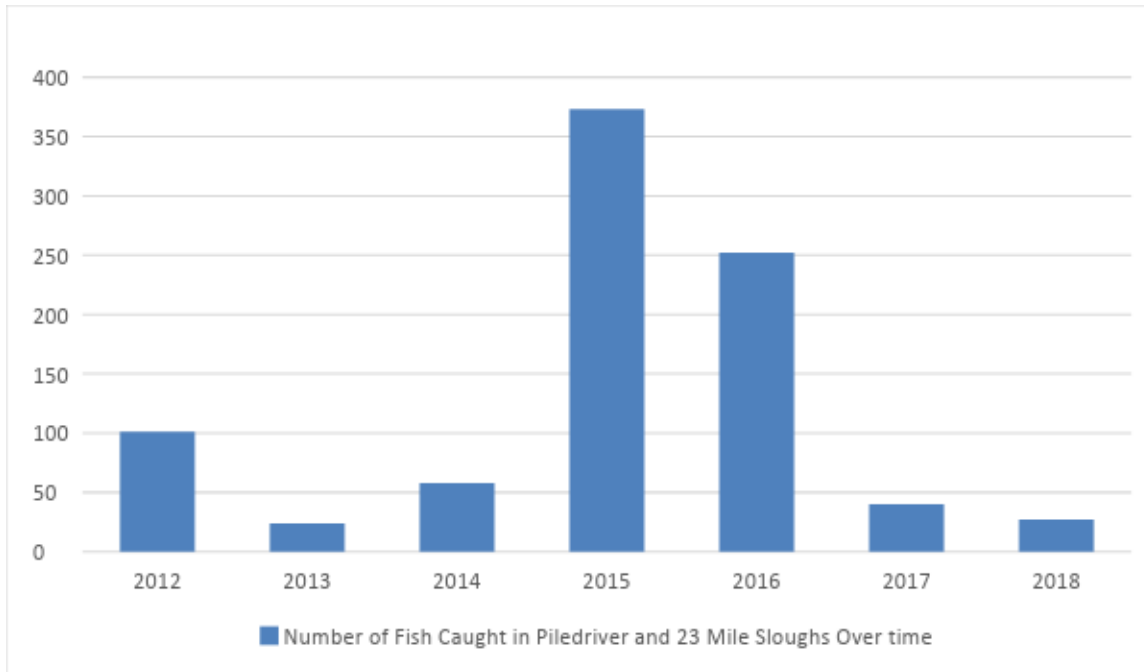
Figure 2: Number of Juvenile Fish Caught in Piledriver and 23 Mile Slough Annually

The drop in fish numbers between 2015/16 and 2017/18 is due largely to the lack of lake chub. We believe this was because our dates were slightly different this year and we did not fish while the lake chub were spawning locally. There is not yet enough data to determine a significant trend in fish numbers.

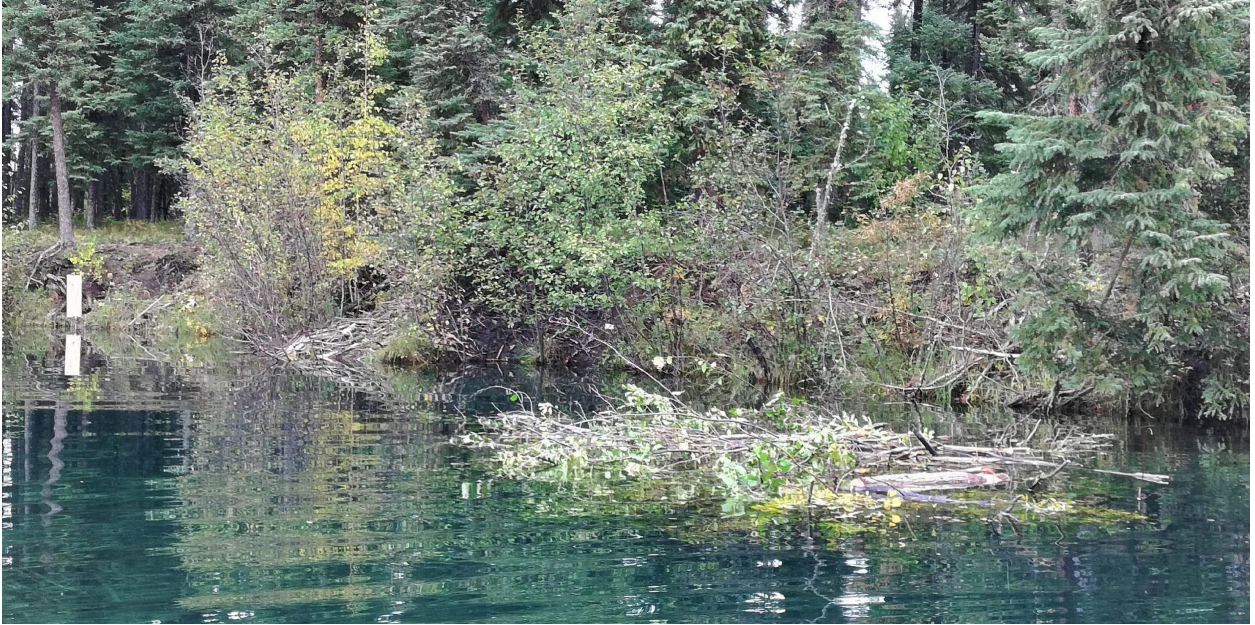
Site 0:

During the September float, TVWA contractors noted that an old lodge site was clearly re-inhabited. A large feed pile located close to the entrance of the lodge was stocked full of fresh alder, willow, and birch indicating that the beavers will over-winter at this lodge.

Large feed pile in front of lodge site comprised of fresh alder and birch found on September float.

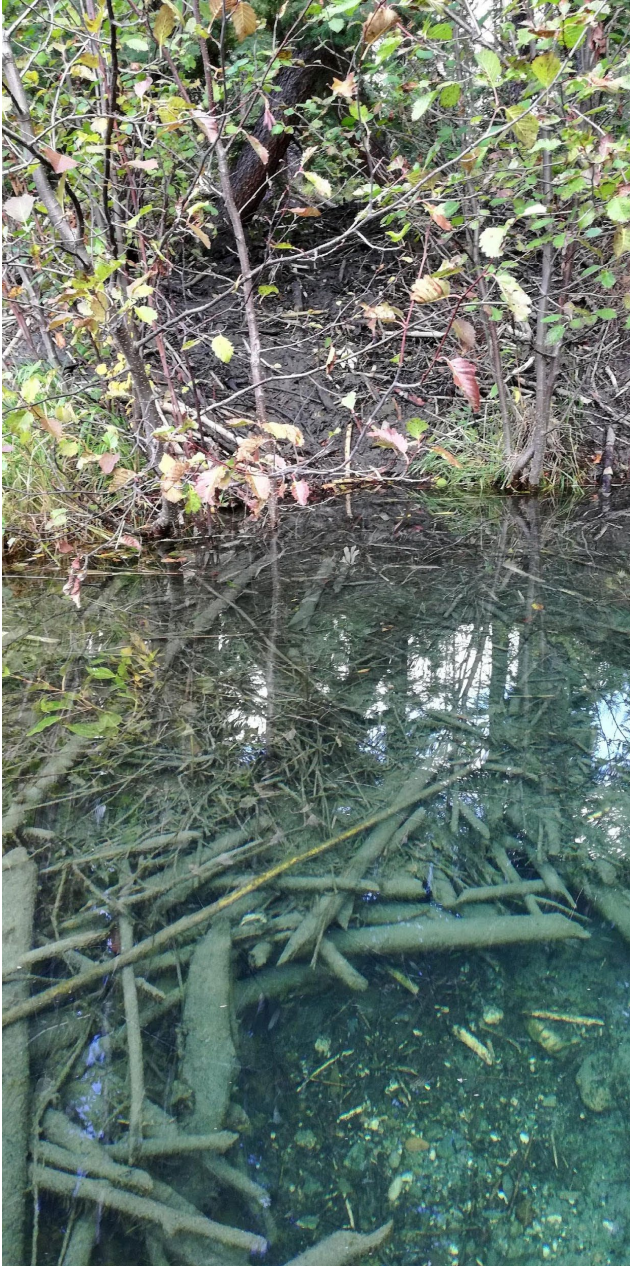
One can see the entrance to the lodge as well as fresh mud and debris used to reinforce it on top.

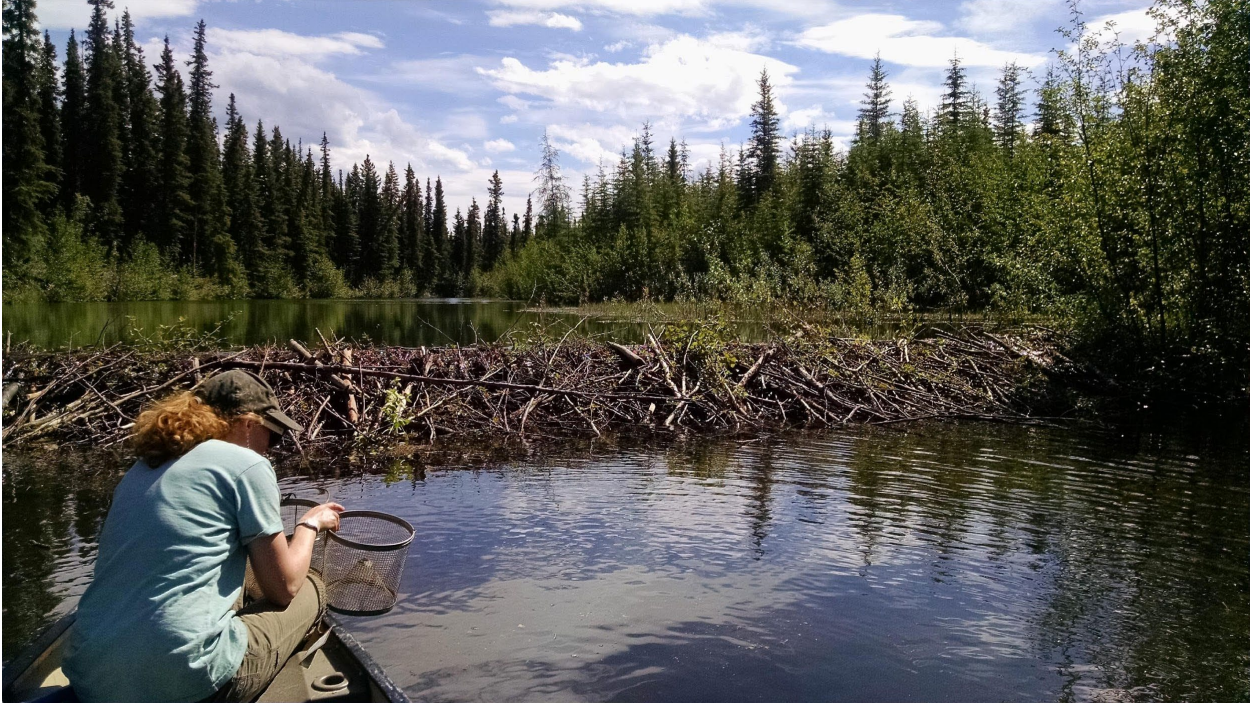
A primary dam was found downstream of the lodge at site 0 and Alan Cady's property. This dam was 3 feet tall and blocked all passage during June and September floats. TVWA contractors punched a 2-foot hole in the dam during the September float to allow for some fish passage.

Setting fish traps below site 1 in June. Note complete blocking of passage.

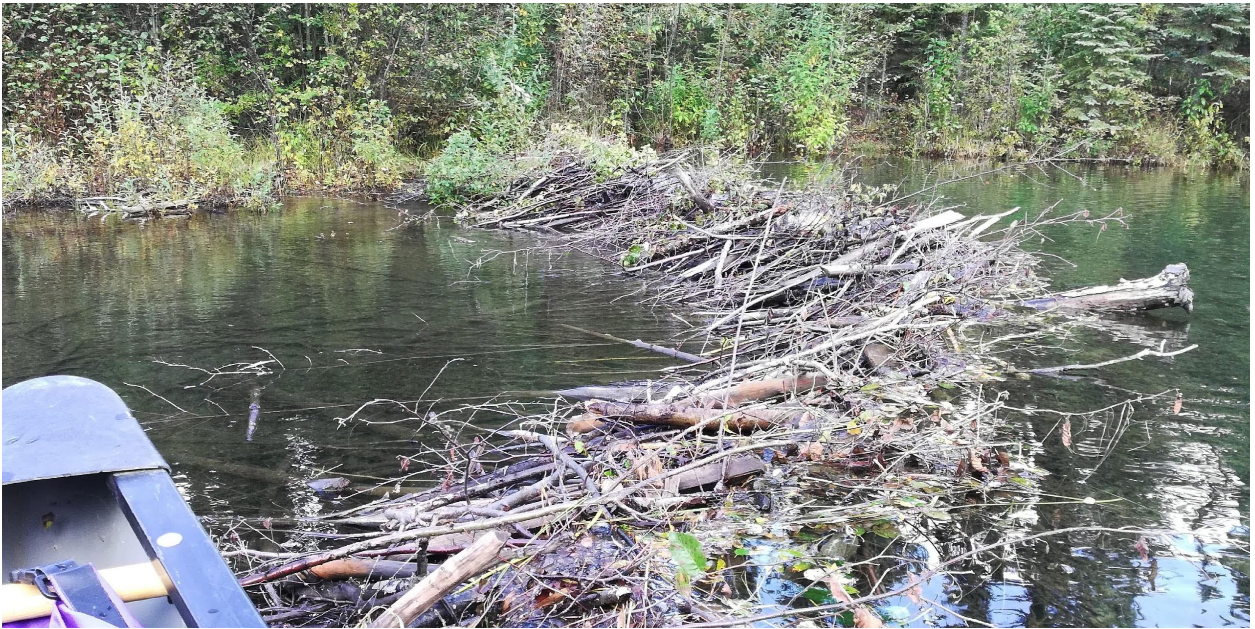
Site 1: The site 1 dam in September. Note the small diameter brush.

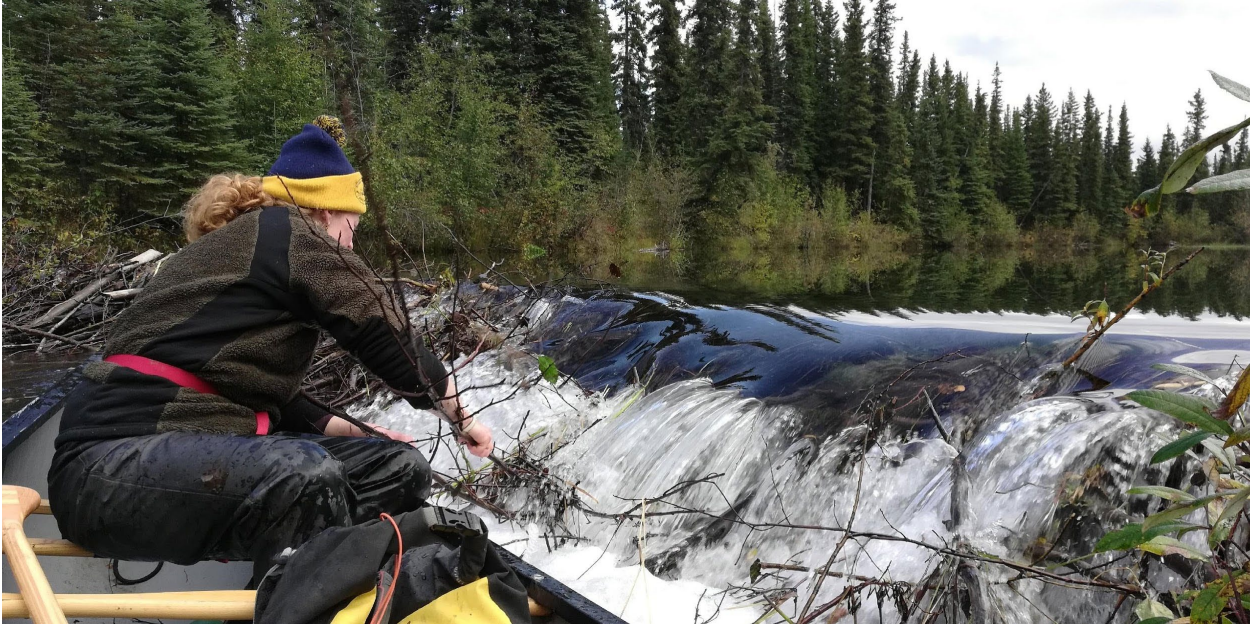
Site 1: TVWA contractor Jenna Jonas removes some of site 1 dam.

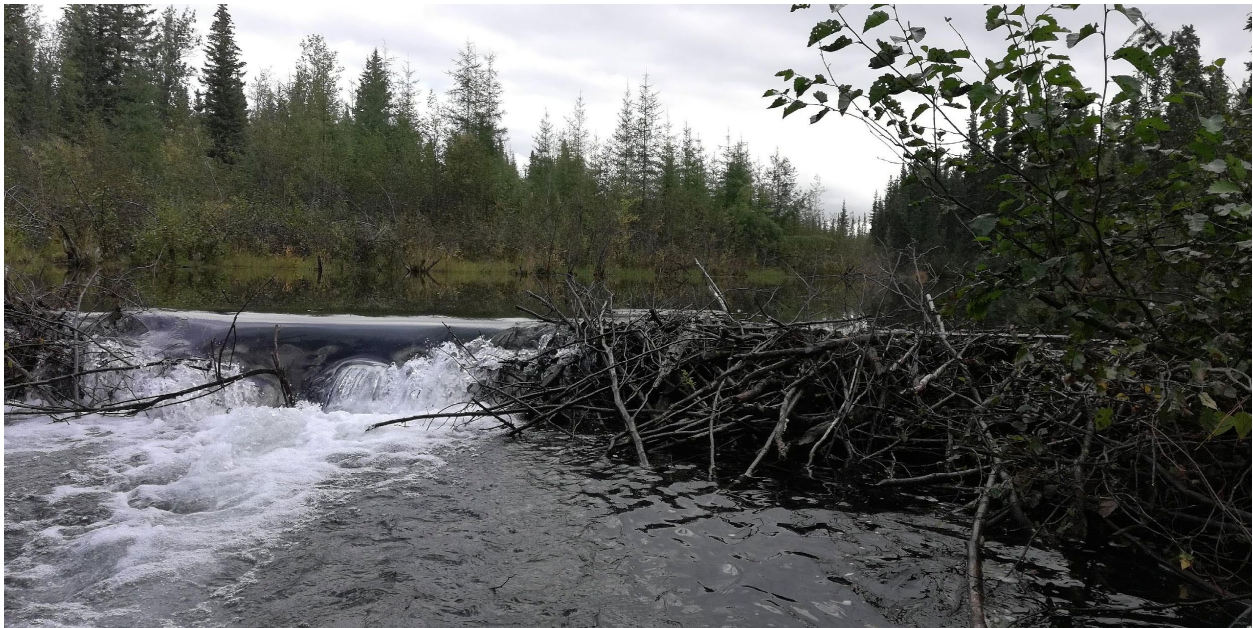
The resulting hole in the site 1 dam.

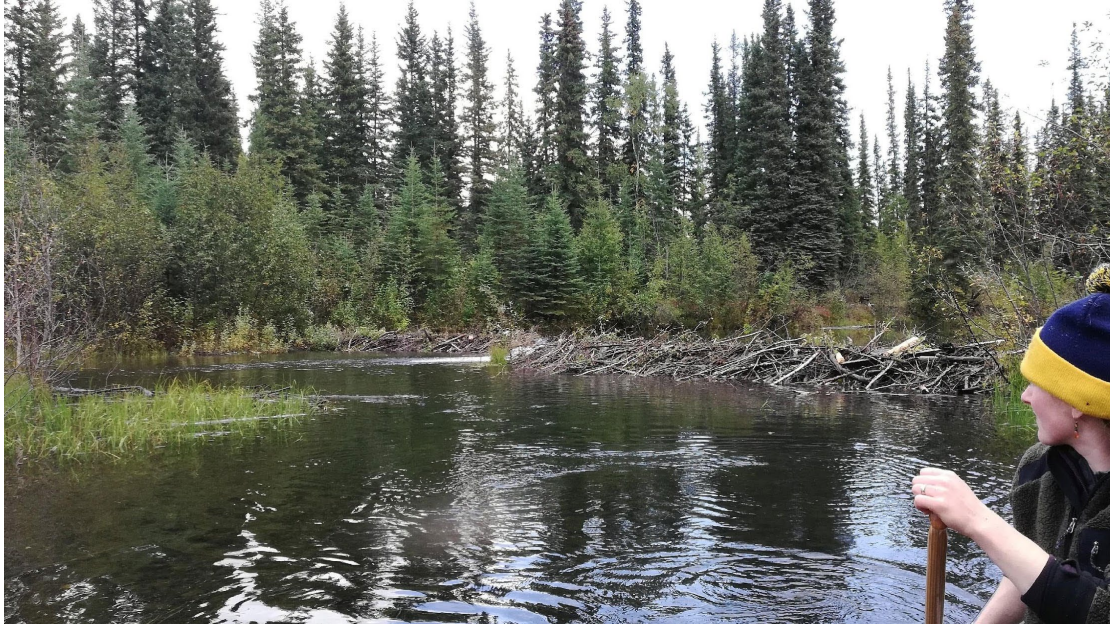
Site 2:

This is a secondary dam located downstream of site 1 dam. It similarly blocked passage and a 2-foot section was removed during September sampling.

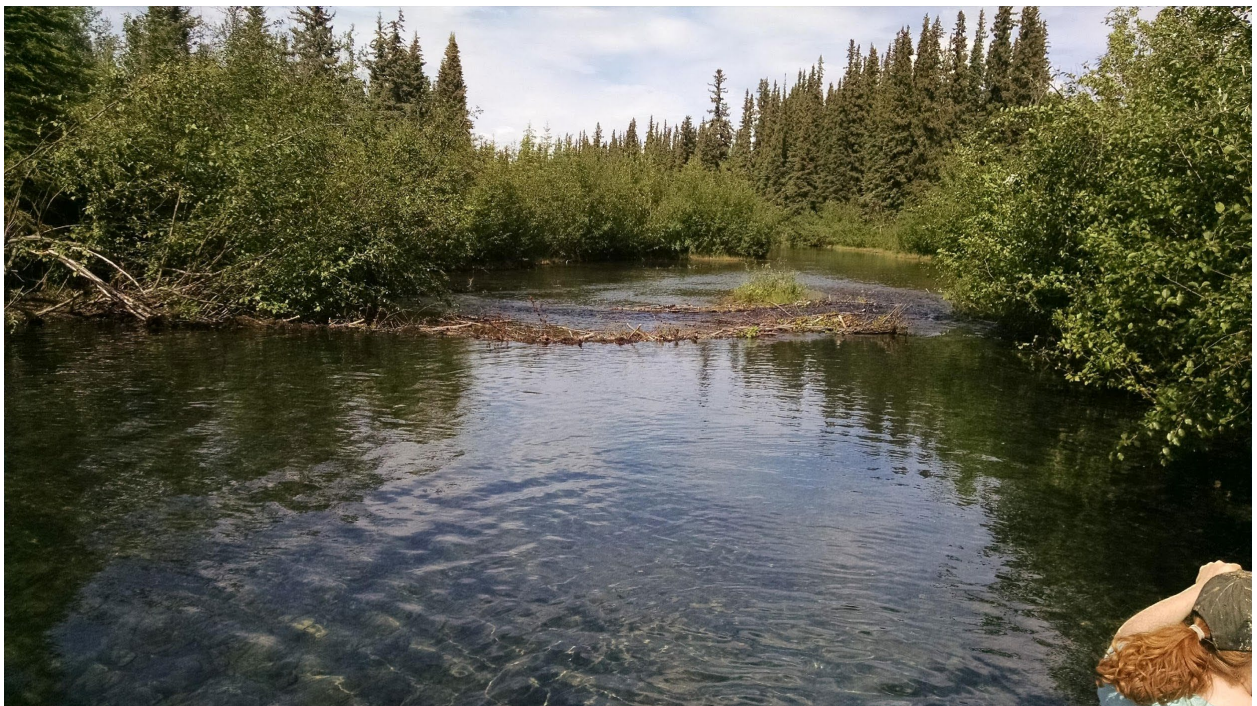
This dam is much farther down Piledriver slough than the first two. We observed that it grew from June to September sampling dates. It is at a natural narrow spot in the slough and during the September float, this was still not fully blocking passage. We suspect that this dam is associated with beavers that have been observed by the Bailey Bridge takeout area rather than the ones occupying the area by the Cady property upstream.

Site 4 during the June float.

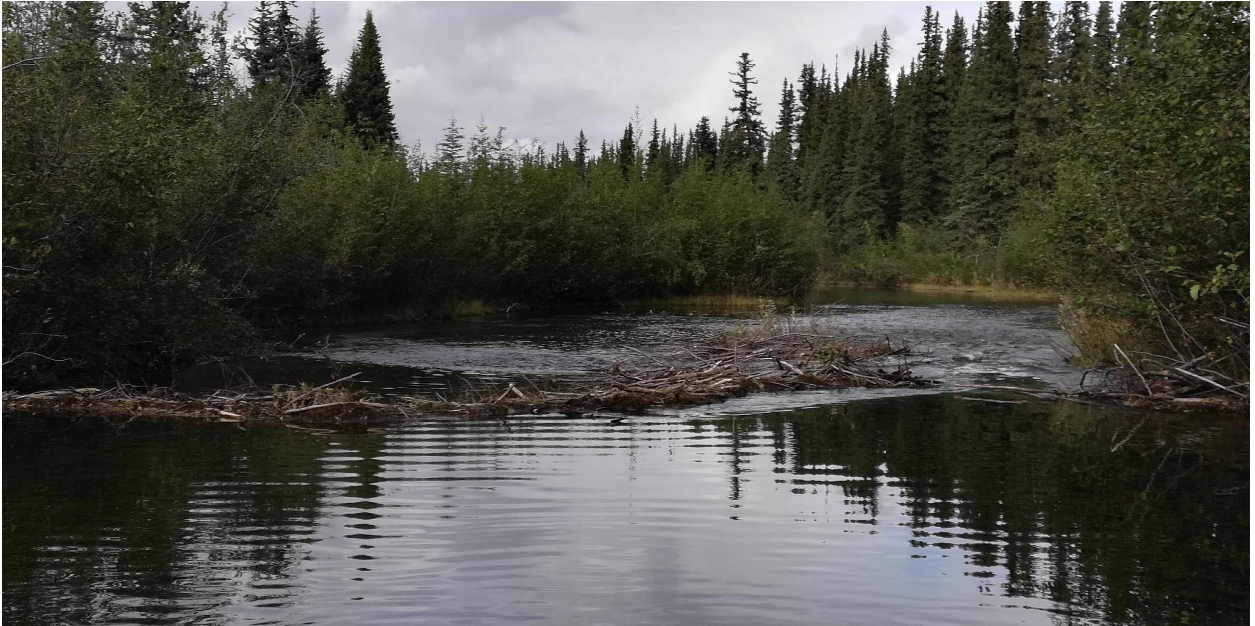
Site 4 during the September float. Note the passage on the far right.

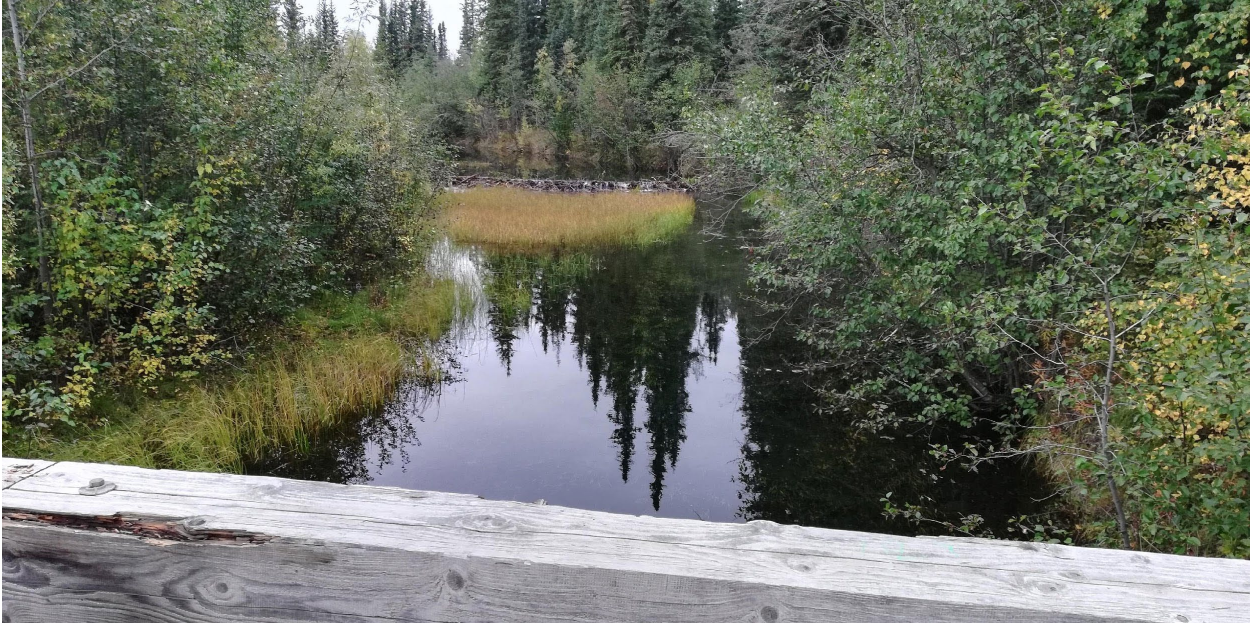
Site 5: A new large dam was noted just upstream of the bridge on 23 mile slough. This lodge was not present during June sampling but was fully constructed in September.

Site 5 lodge during September sampling.

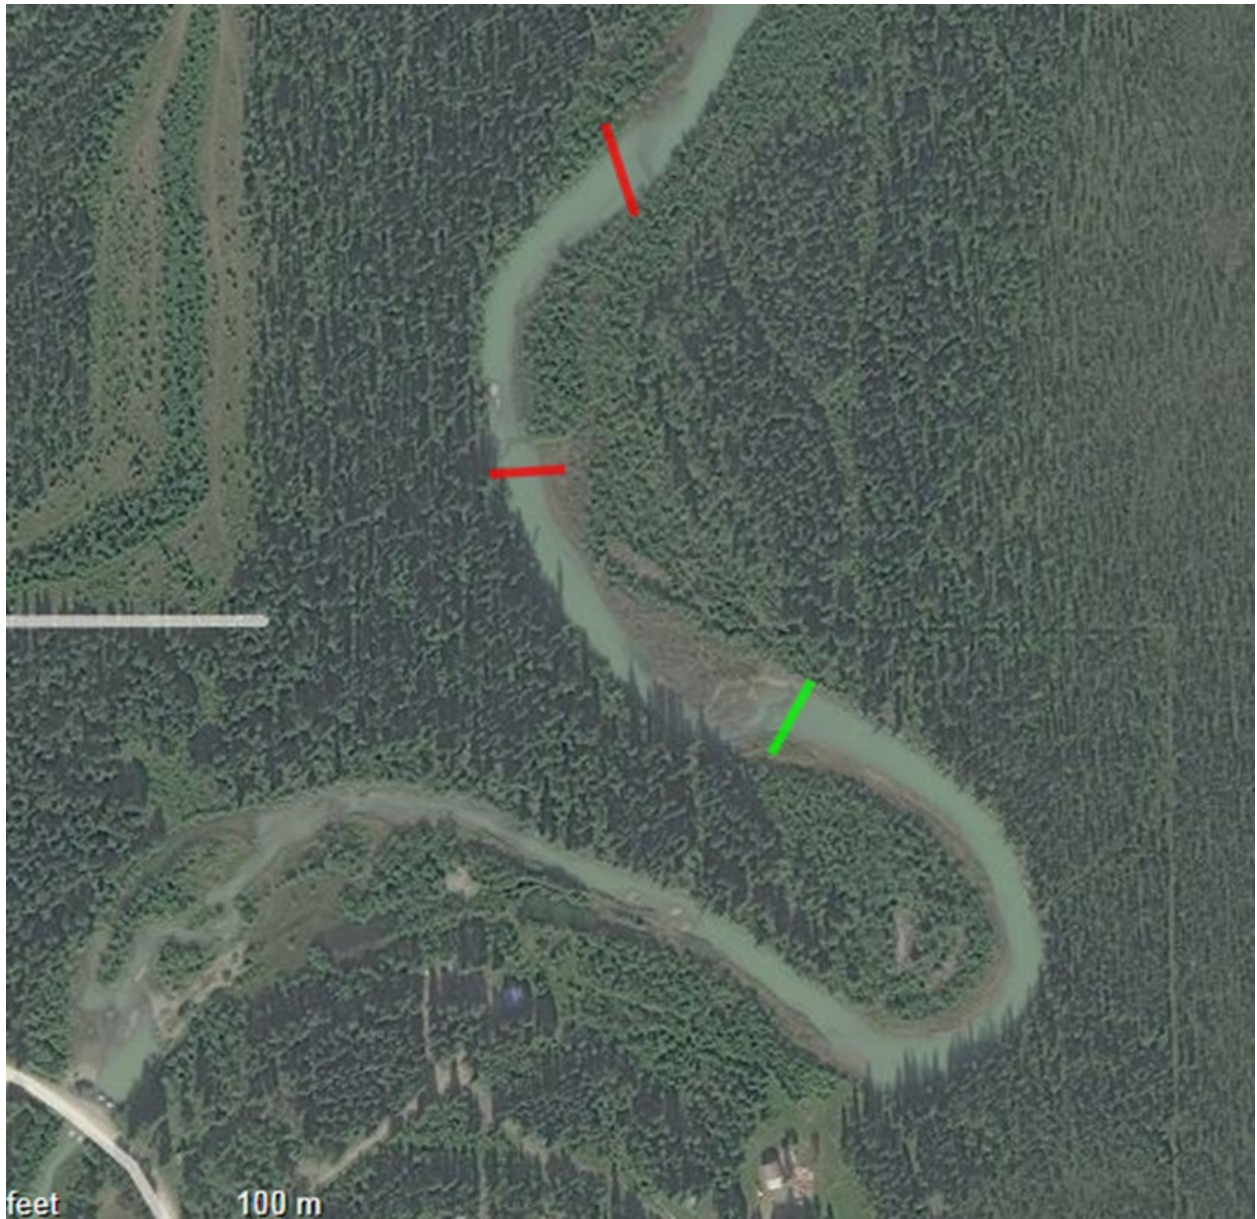
Figure 1. Dam 1 in Green was the primary dam, Dam site 2 is shown as the top red line.

The location of the problem dams site 1 and 2 was close (1/2 mile approximately) from the uppermost limit of the observed spawning area (by the Barnes' property). Without removing or killing the beavers, there was little point in removing the dam as it would be swiftly rebuilt. TVWA contractors made a small breach on Sept 4 in the primary and secondary dams. We will continue to correspond with ADFG, the Railroad and Mr. Cady about this dam issue in the future.
