# Riparian Conditions of the Lower Chena River

Erik Friele Lie, student, Natural Resource Management, University of Alaska Fairbanks

Submitted December 2012

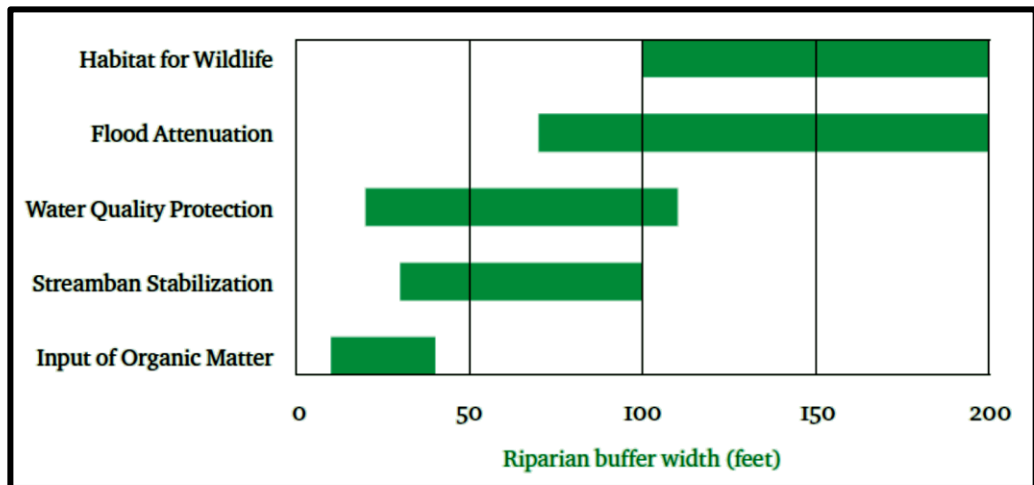
**Figure 2:** The range of recommended riparian buffer widths encountered by Fischer and Fischenich (2000) in their review of riparian buffer literature. The widths for “Habitat for Wildlife” and “Flood Attenuation” were truncated before the very large values of 1600 feet and 490 feet, respectively. Figure from Coles-Ritchie (2009).

The choice to distinguish areas wider and narrower than 50 feet was based on information compiled by Coles-Ritchie (2009). It can be argued that a minimum buffer zone of 50 feet is too narrow (see Figure 2). However, Coles-Ritchie (2009) also recognizes that some conditions make it impractical to implement recommended buffer width, for example where there already is a high degree of development, like in the Fairbanks city area.

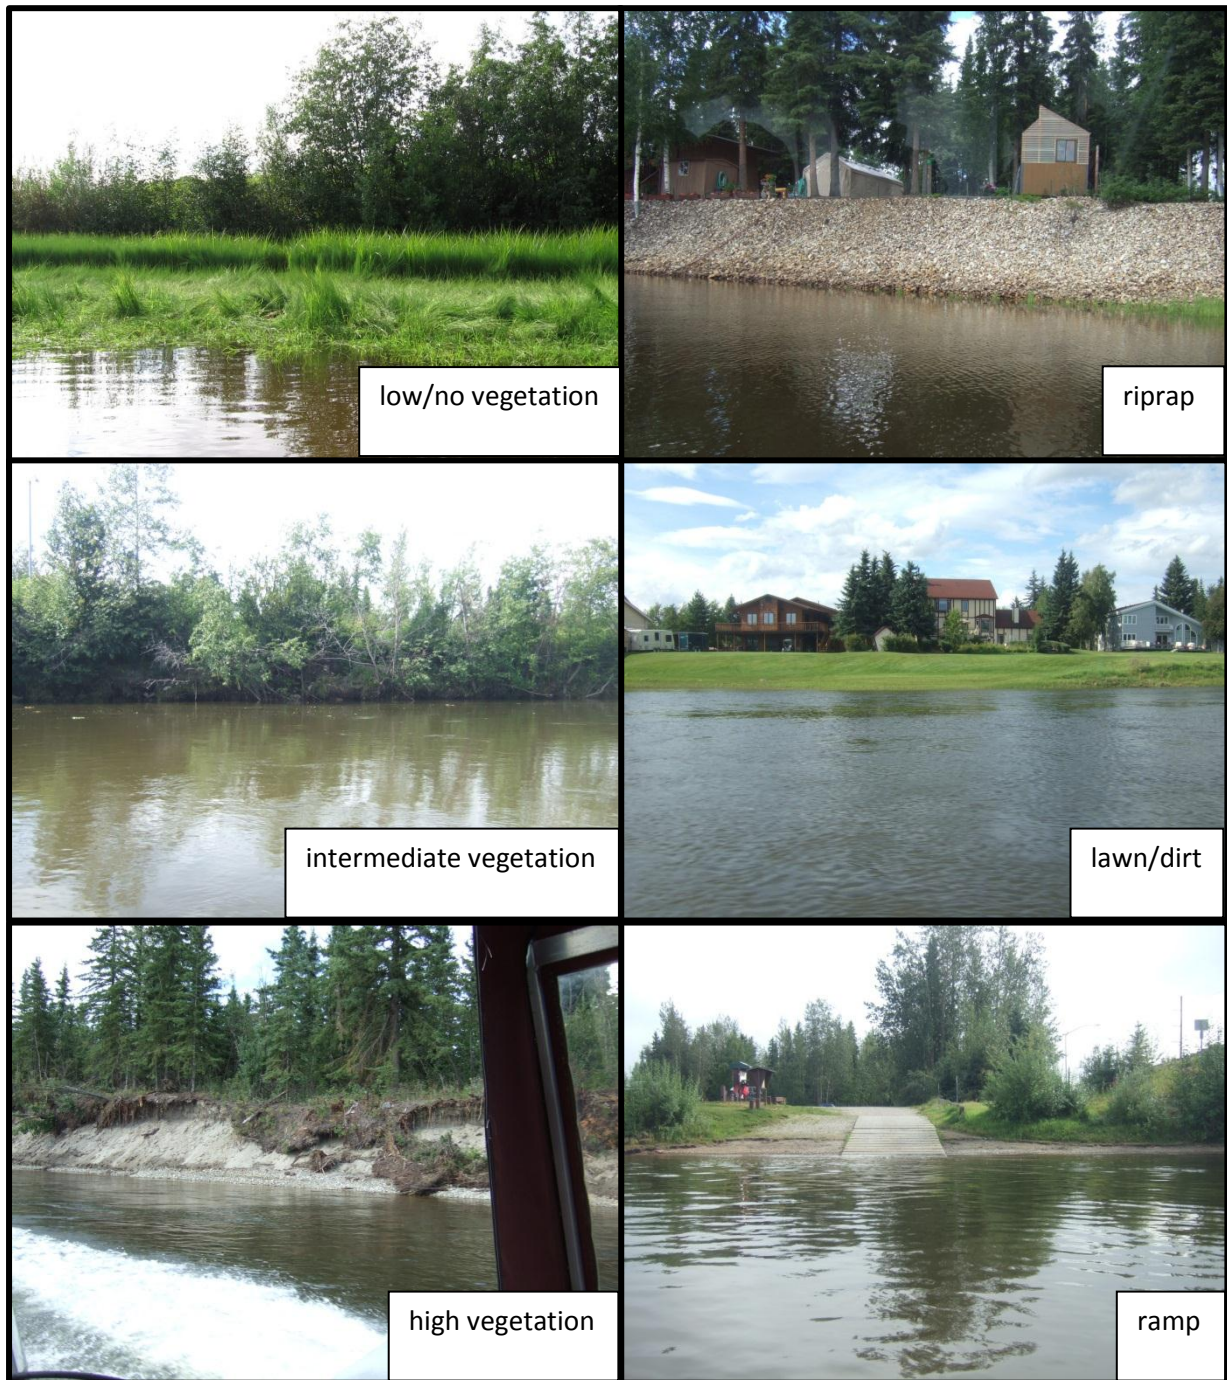
**Figure 3:** Representations, from the Chena River, of some of the riparian “types” that the riversides were categorized within. “Natural” conditions to the left, “unnatural” conditions to the right. All photos: Bob Henszey.

If the riverside is in a “natural” condition, one of the following riparian types is assigned to the segment (Figure 3):

If the riverside is in an “unnatural” condition, one of the following riparian types is assigned to the segment (Figure 3):

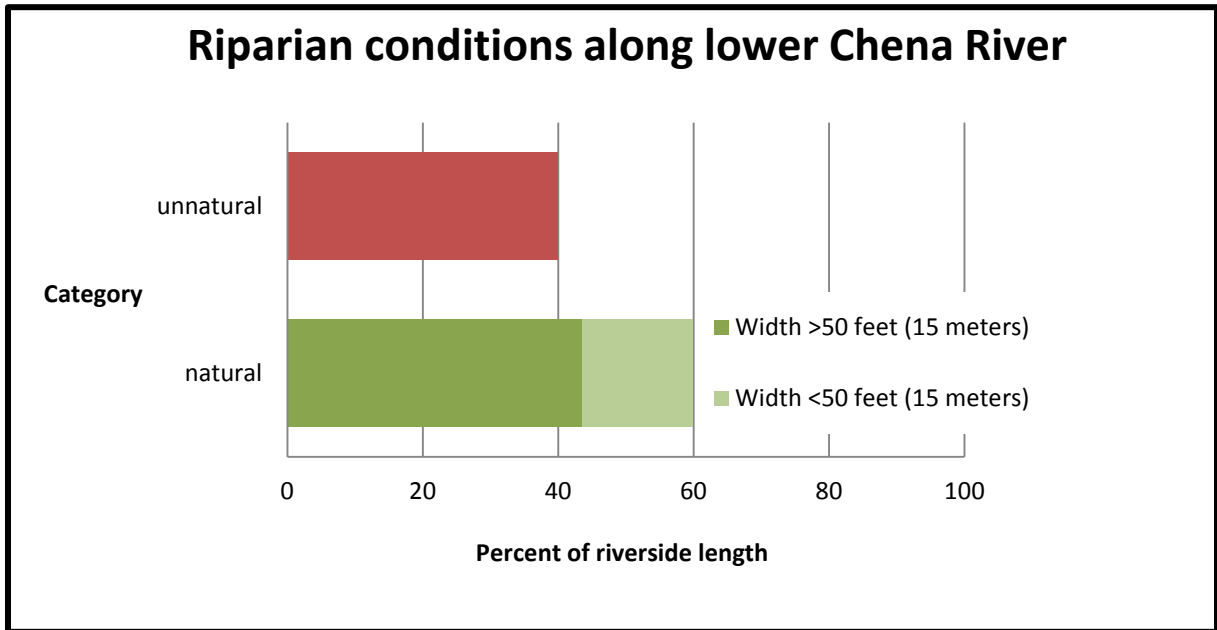
**Figure 5:** Distribution in percentage of «natural» and «unnatural» riparian conditions along the lower Chena River.

Figure 5 shows the distribution in percentage of “natural” and “unnatural” riparian areas along the lower Chena River.

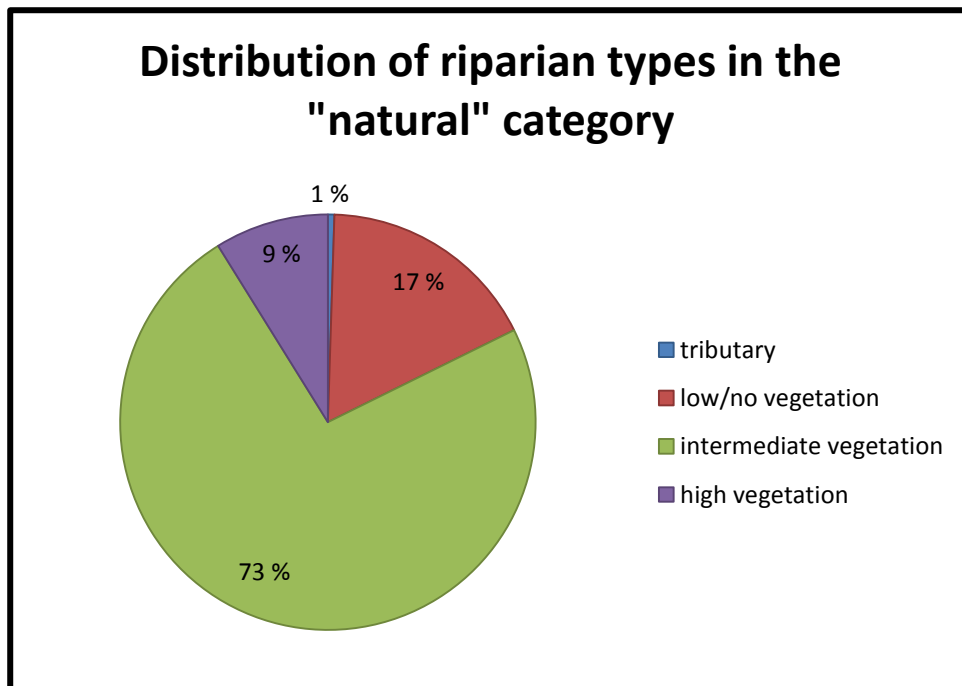
**Figure 6:** Distribution of the different types of “natural” riparian conditions along the lower Chena River (both “width” categories combined).

Figure 6 shows the distribution in percentage of the different types of “natural” riparian conditions.

At this time, the most common type of natural vegetation along the lower Chena River is “intermediate vegetation”, that is, shrubs and low trees. Different vegetation types have different impact on a range of patterns and processes, including hydrological and ecological (Lyons et al. 2000; Tabacchi et al. 2000). This can be considered in management and restoration of riparian areas.

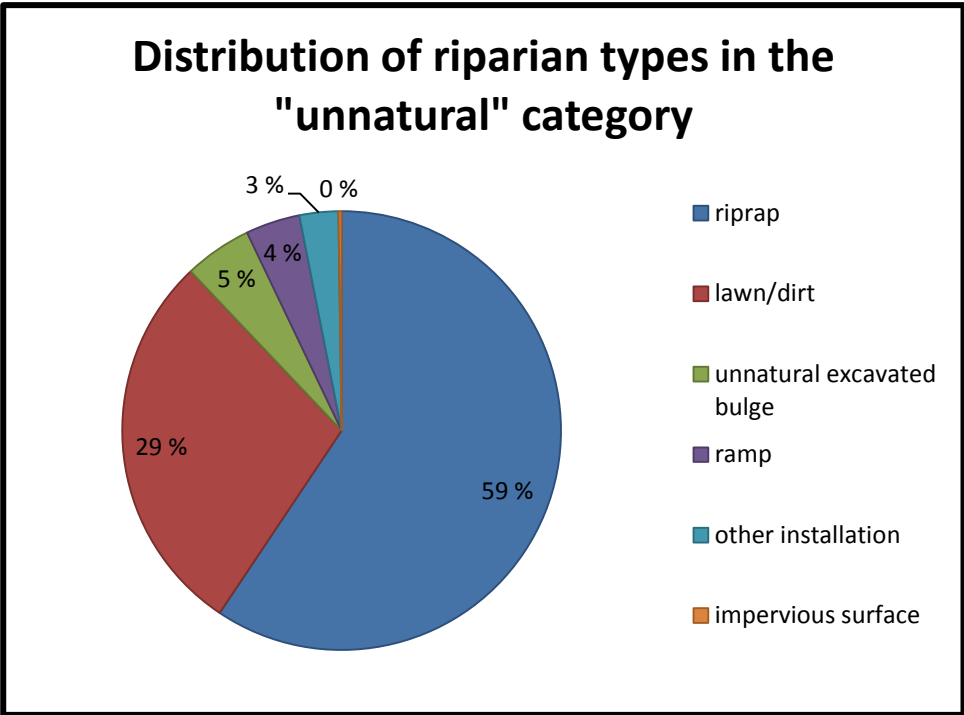
**Figure 7:** Distribution of the different types of “unnatural” riparian conditions along the lower Chena River. The part of “impervious surface” was less than 0.25 %.

Figure 7 shows the distribution in percentage of the different types of “unnatural” riparian conditions.

The most common “unnatural” riparian types are “riprap” and “lawn/dirt”. Together, these categories make up almost 90 % of the “unnatural” parts of the lower Chena River. The main reason for constructing riprap along a riverside is usually to stabilize and prevent erosion of the bank. However, downstream of a riprap construction it will become greater stream velocity and possibly
